Re: University Village Apartments Partial Walkway Collapse
Cause of Failure Report

THHinc #7429

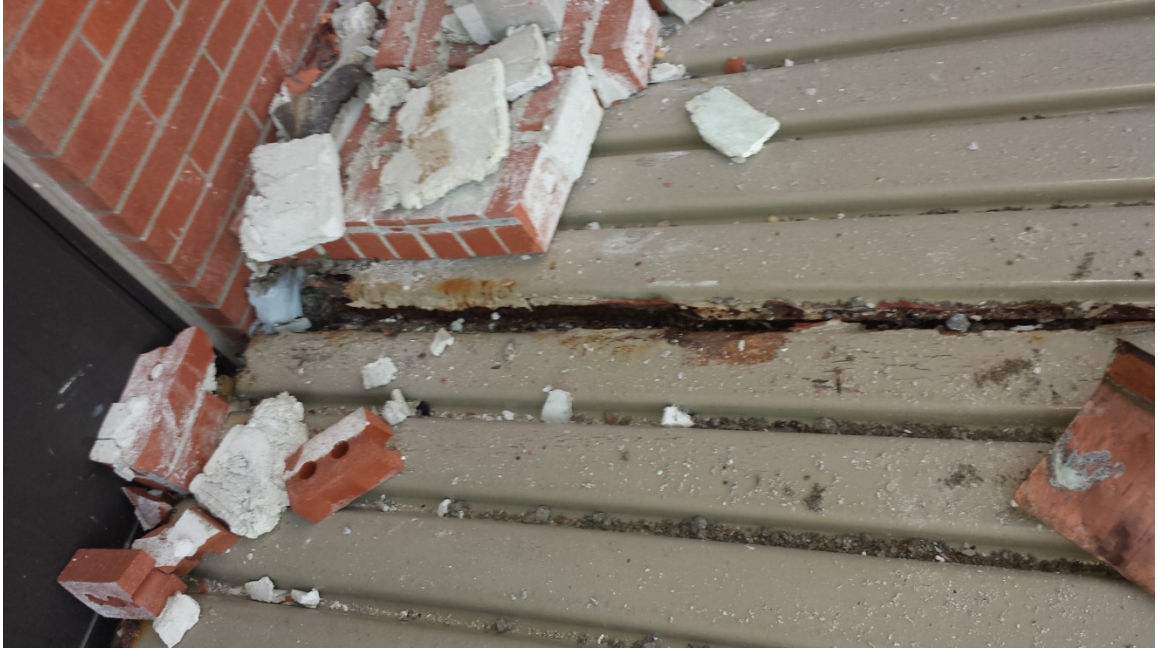
heavily corroded and portions of the concrete slab were delaminated and showed signs of severe weathering. In addition to the deterioration at the outer edge a few longitudinal cracks in the steel deck were observed that extended nearly the full width of the walkway.

Photo 1: Longitudinal Corrosion and Crack in Metal Deck

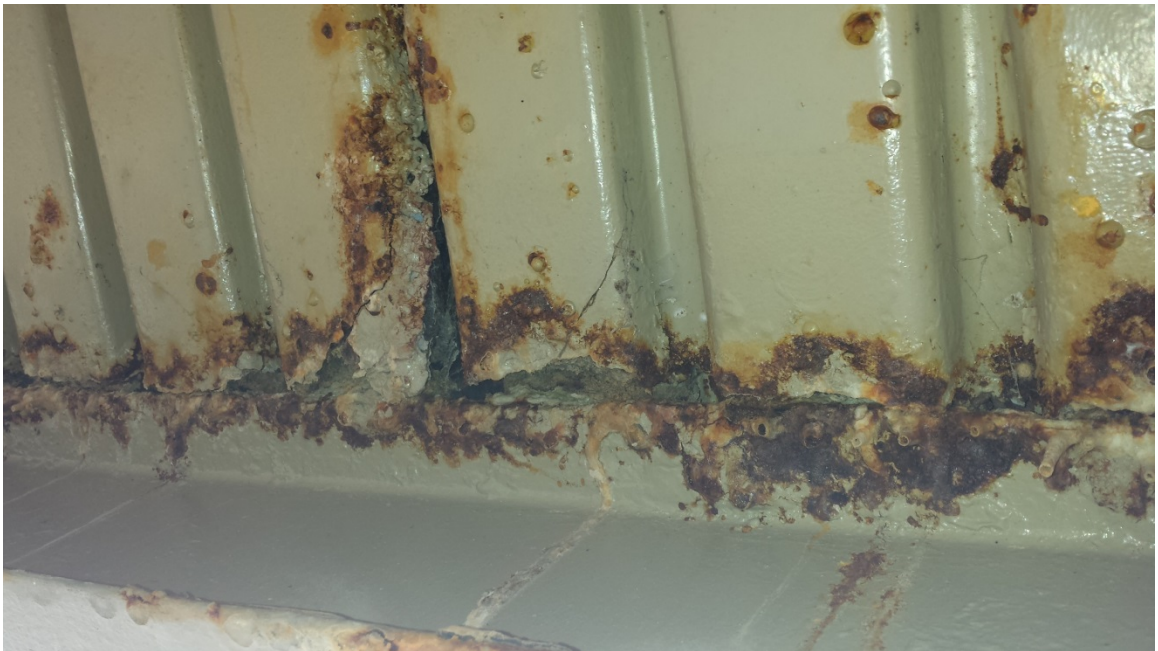
Photo 2: Deterioration at Front Edge of Remaining Walkway

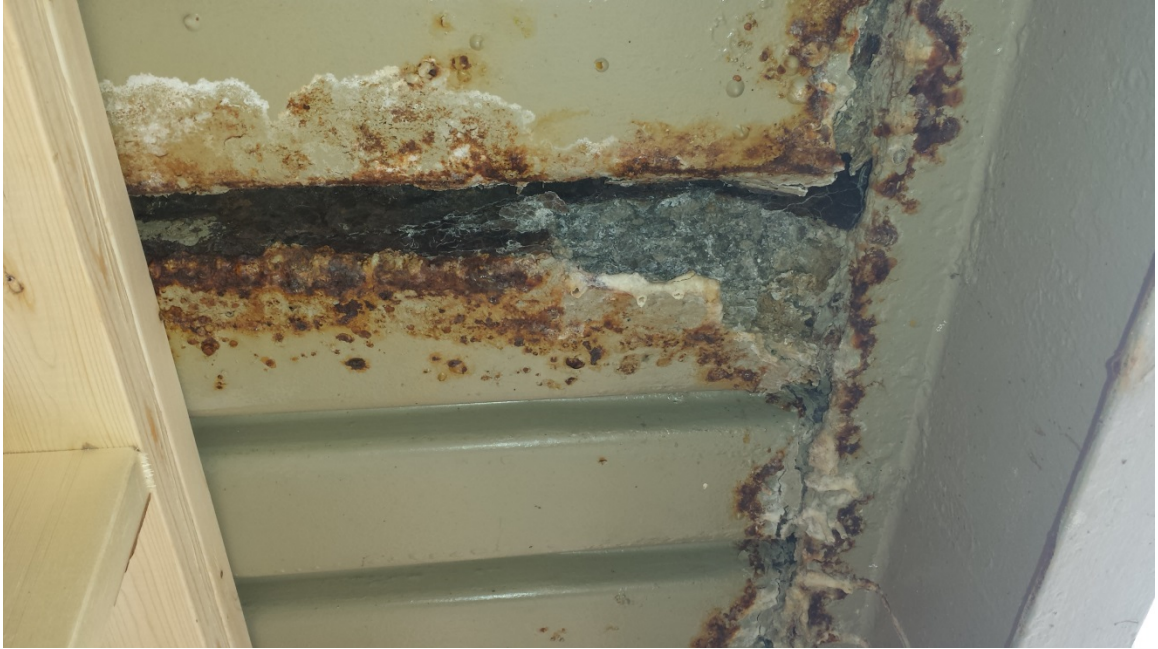
Photo 3: Deterioration at Front Edge of Remaining Walkway

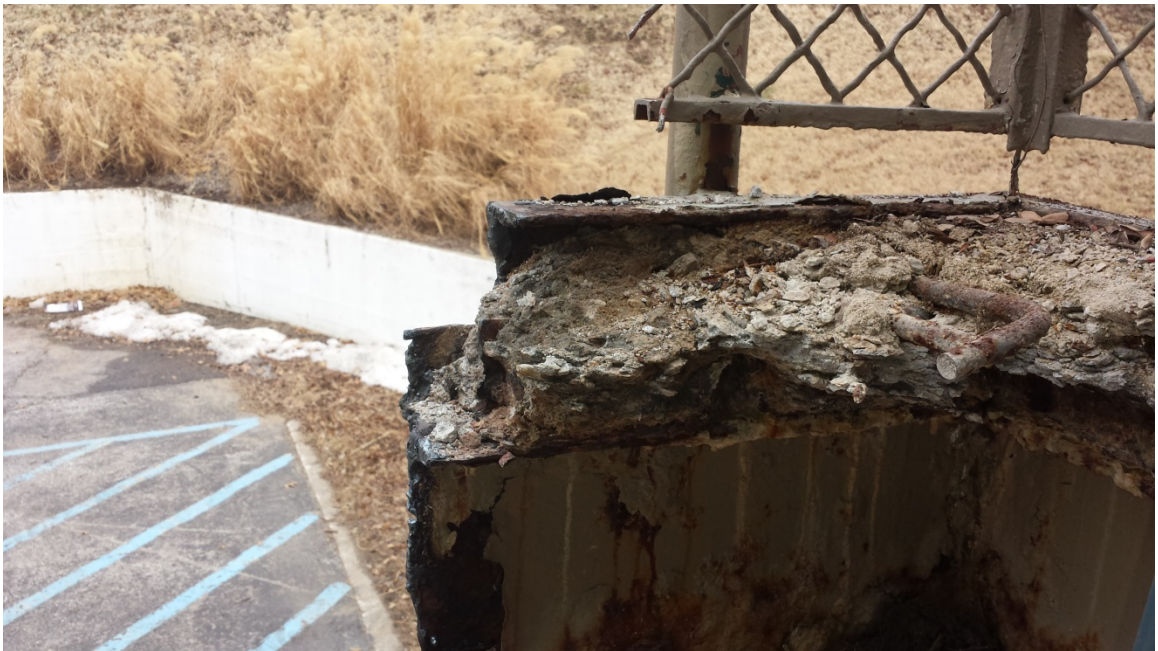
As described above all of these components were severely deteriorated which makes it very difficult to pinpoint precisely what happened based solely on the observed debris. Additionally, surveillance video or reliable firsthand reports have not been made available. However, we are confident that the collapse was a result of a concrete shear failure along the outer edge. It is likely that water and chlorides, and expansion from freeze-thaw action, combined to deteriorate the concrete to the point where its shear strength could no longer support even only the self-weight of the walkway. The loud “bang” reported by the residents was probably the sound from the shear failure itself. The walkway then likely sagged but remained suspended due to membrane action of the slab supported at the ends and along the face of the building. Once the load surpassed the bond and tension strength of the mesh reinforcing then the slab broke free from the ends and the front edge dropped.

Photo 4: Concrete Shear Failure at Front Edge

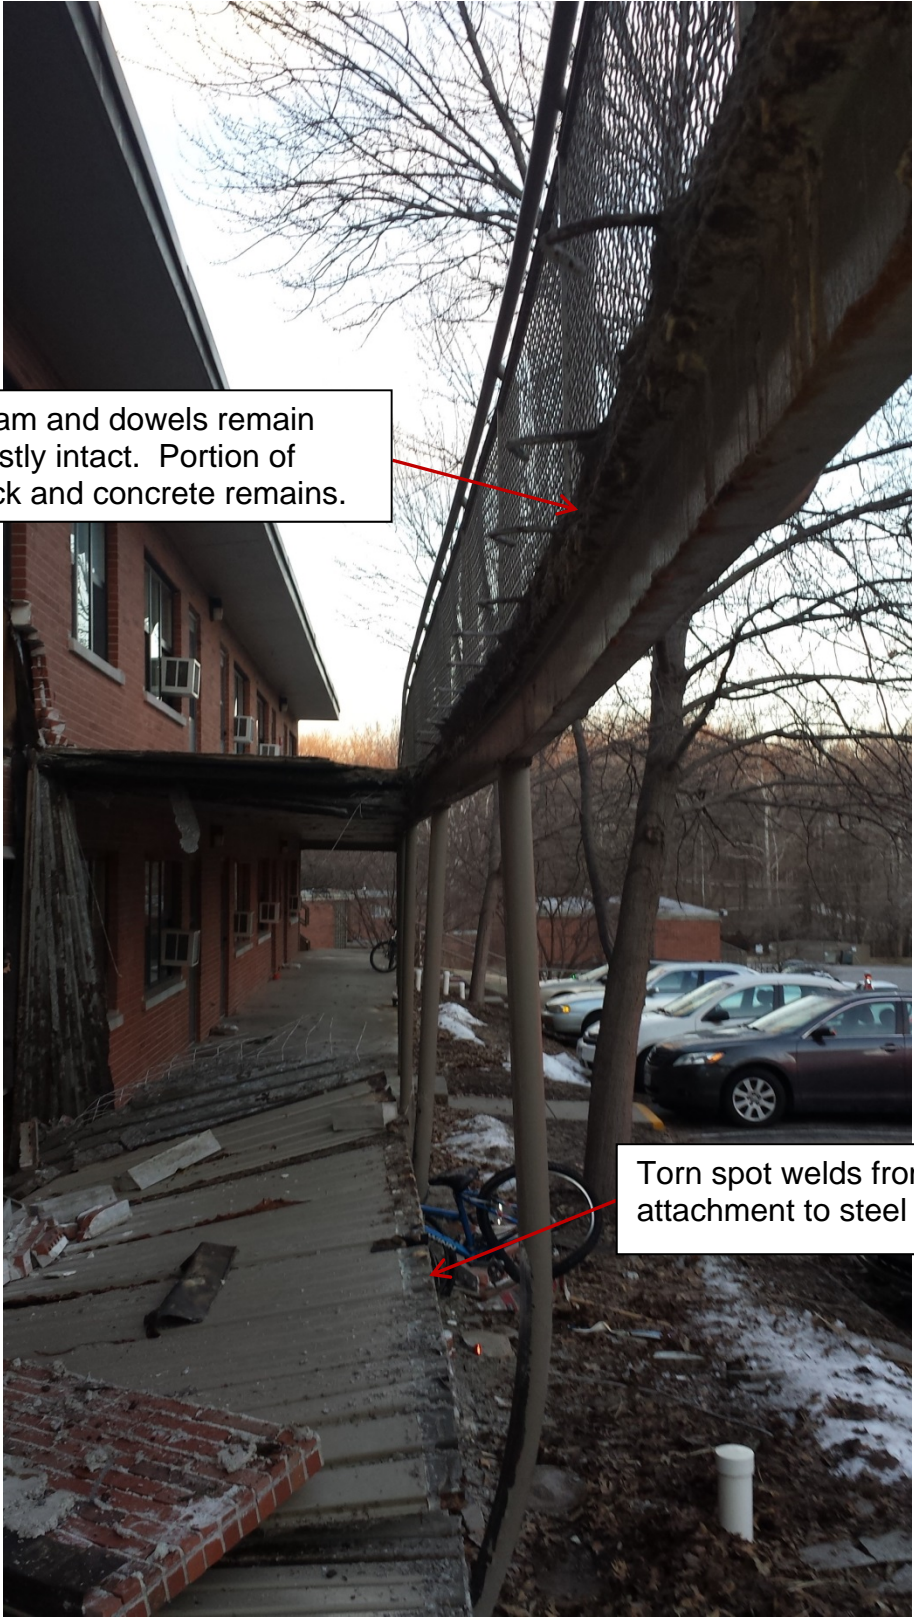
Beam and dowels remain mostly intact. Portion of deck and concrete remains.

Torn spot welds from attachment to steel ledger angle.

Photo 5: Remaining Front Edge Beam, “J” Dowels, Railing & Torn Fasteners
