**SUBJECT:** Transmittal of Final Report - High Lead at Three Residences in Flint, Michigan

## High Lead Levels in Flint, Michigan

The purpose of this report is to present the findings of activities conducted in response to high lead levels in drinking water reported to the United States Environmental Protection Agency Region 5 Office (EPA) by a resident in the City of Flint, Michigan.

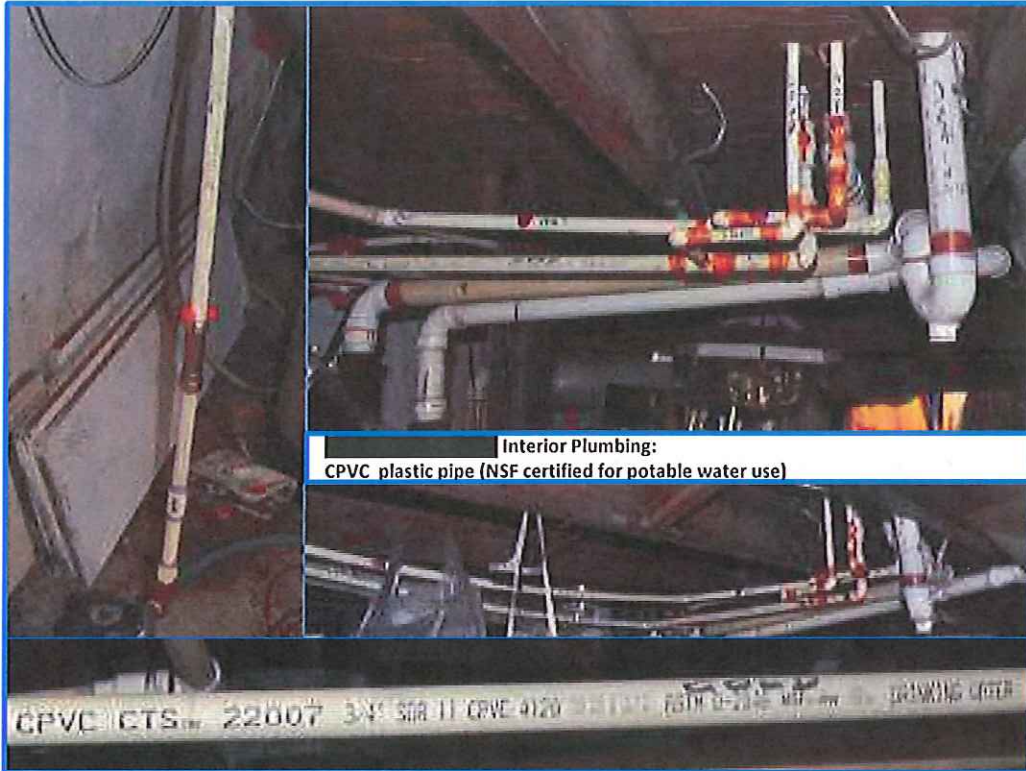
**Internal Plumbing – [REDACTED]**

The following pictures were taken at the [REDACTED] home located at [REDACTED]. With the exception of a few minor metallic connectors, all potable water plumbing in the home was found to be CPVC plastic pipe which is NSF-certified for drinking water use.

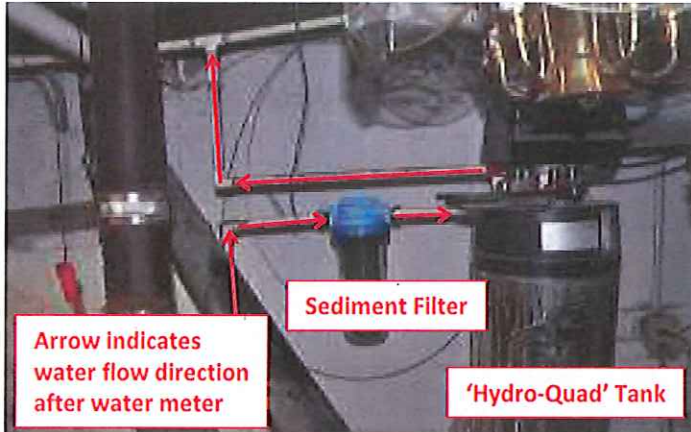
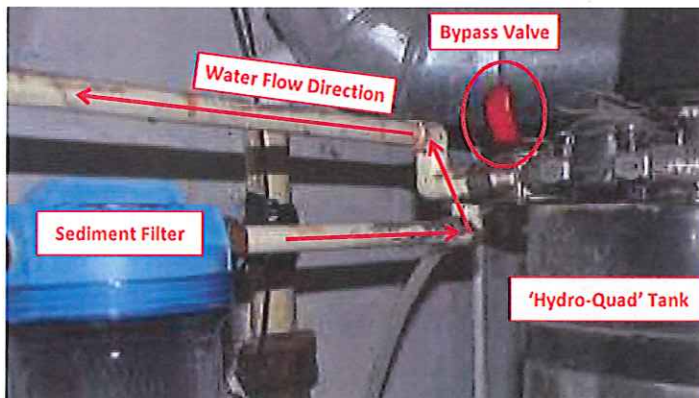
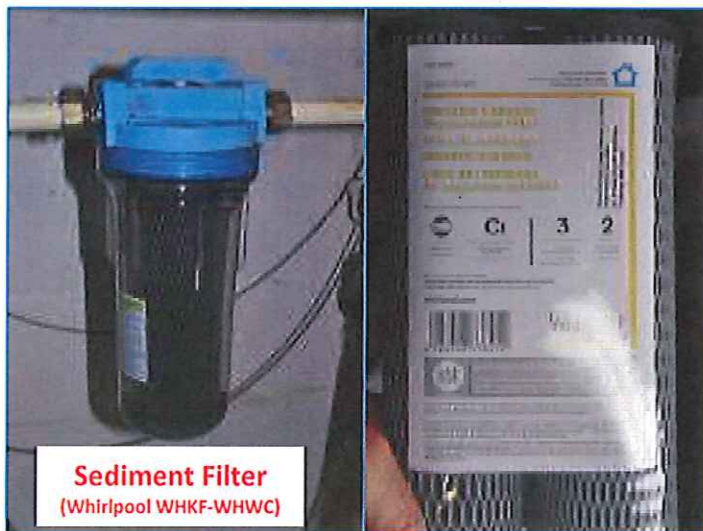
**Treatment Units –** [REDACTED]

The [REDACTED] home has a whole-home sediment filter, as well a non-functioning 'Hydro-Quad Commercial Water Processor' which is bypassed. There was no iron filter in the home as had been previously reported.

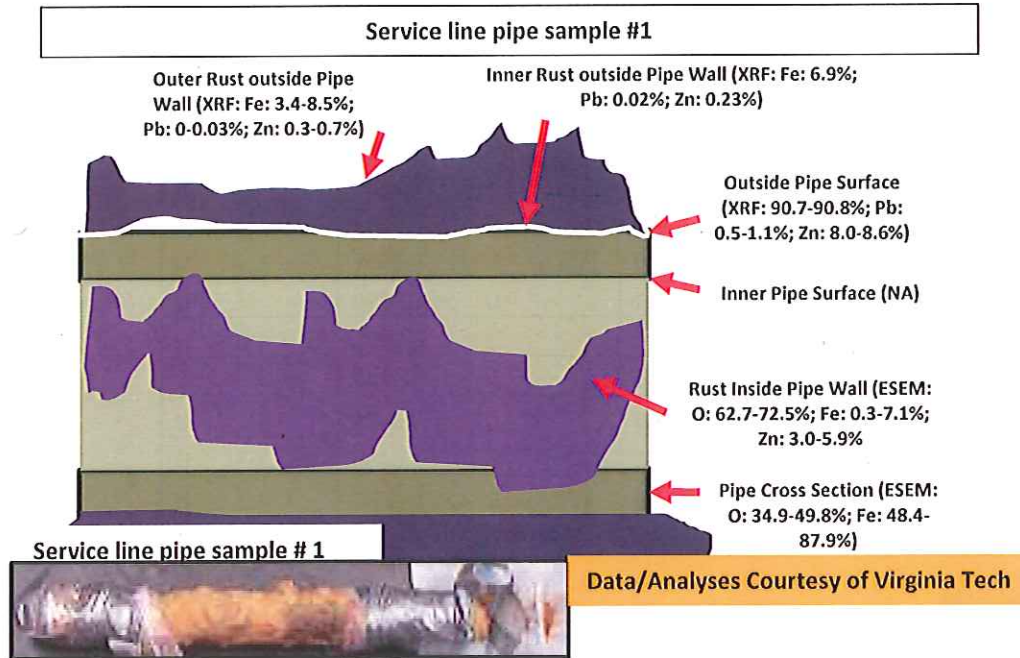
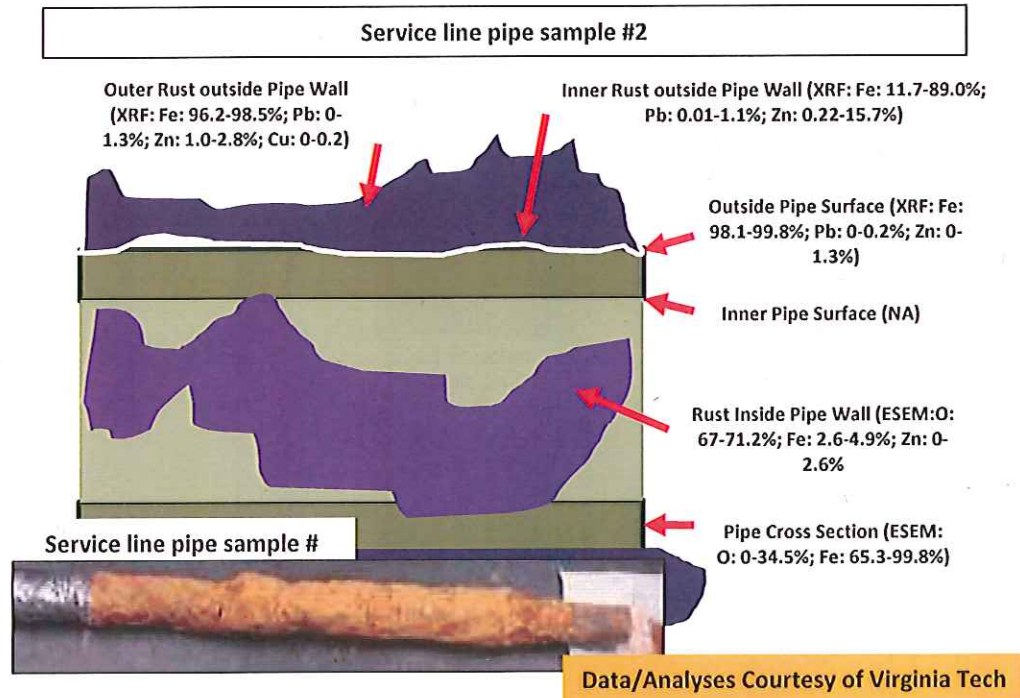
*Analysis of [redacted] original service line pipe (galvanized iron portions)*

Below are the results of the galvanized pipe analyses conducted by Virginia Tech on the two sections of galvanized iron pipe from the [redacted] original service line. The analyses indicate that the [redacted] original service line was a typical galvanized iron pipe.

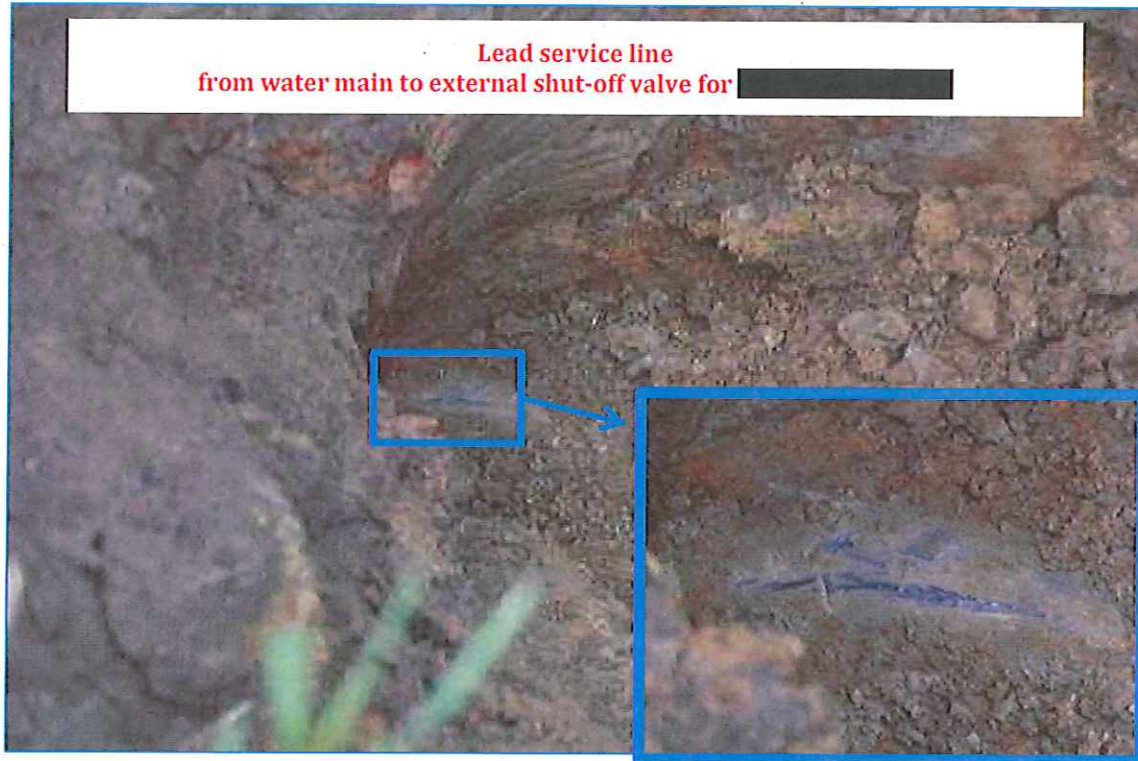
Lead portion of the [redacted] original service line

Lead service lines can contribute up to 75 percent of the total mass release into the water. The portion of the [redacted] original service line from the water main to the external shut-off valve at the corner of [redacted] and Bryant Street is made of lead and is estimated to be approximately 25 feet in length.

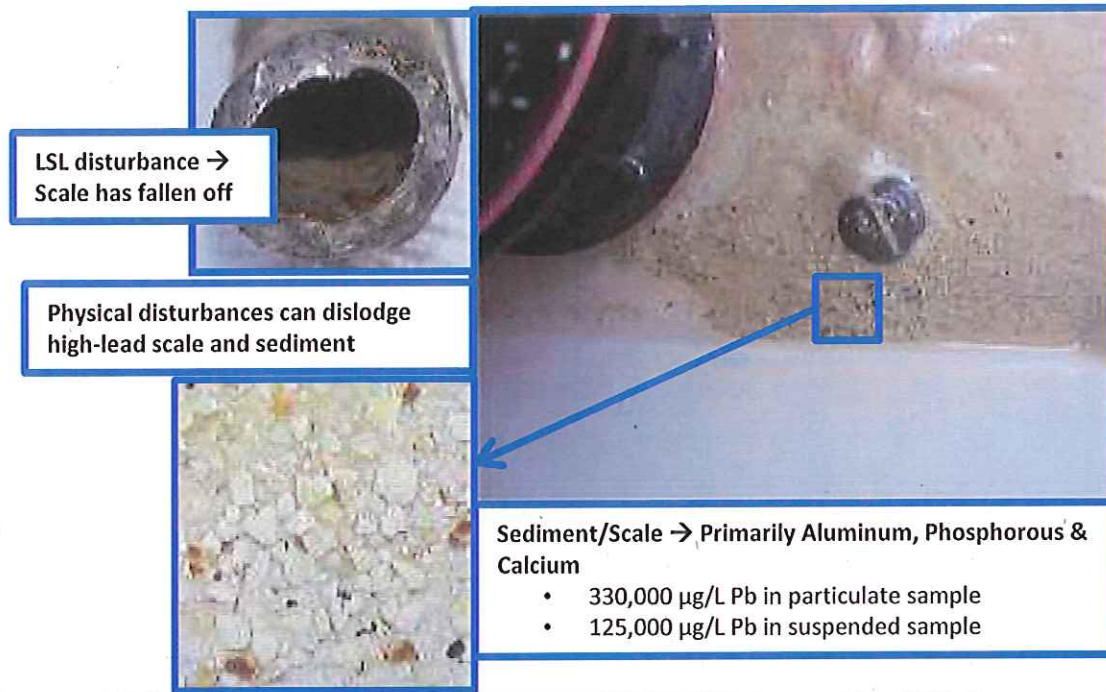
*Physical disturbance of lead service lines*

A recent EPA study indicates that physical disturbances to lead service lines or in proximity to lead service lines can cause the dislodging of the protective scales from within the lines. The photograph below shows the scale that was dislodged from inside a lead service line during routine maintenance work in another city due to a physical disturbance of the line. The dislodged scale and sediment contained a very high concentration of lead.

Lead service line disturbances were found to be a common factor for the majority of sites with high lead levels. It is also possible that low water usage may play a role in sites with the highest lead levels.

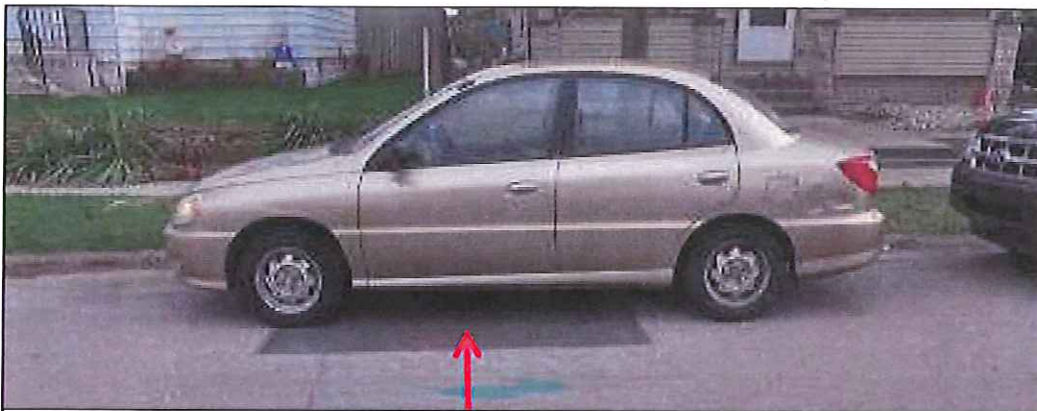
While visiting the [redacted] home, two fresh patches of asphalt were seen along the parkway where the [redacted] original service line was located. The jarring and vibration associated with excavation can dislodge the high lead-bearing scales from within the service line pipes.

Recent patch (#1) of asphalt along curb next to the parkway where the [redacted] service line runs.

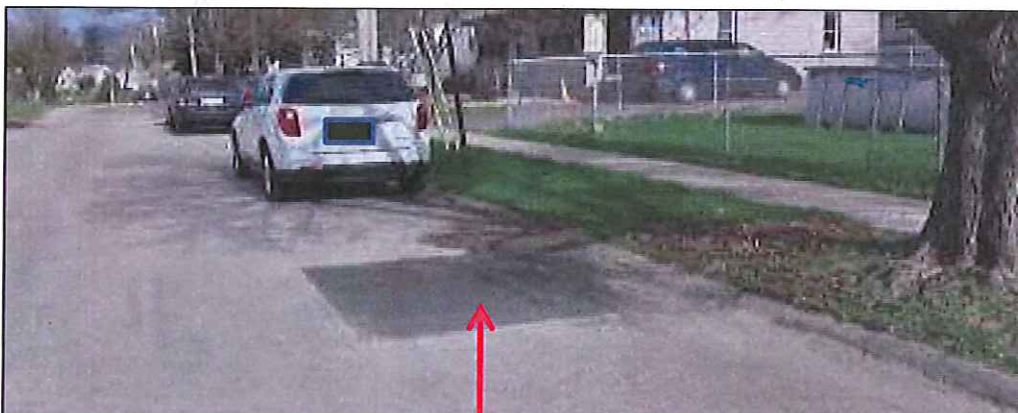
Recent patch (#2) of asphalt along curb next to the parkway where the [redacted] service line runs.

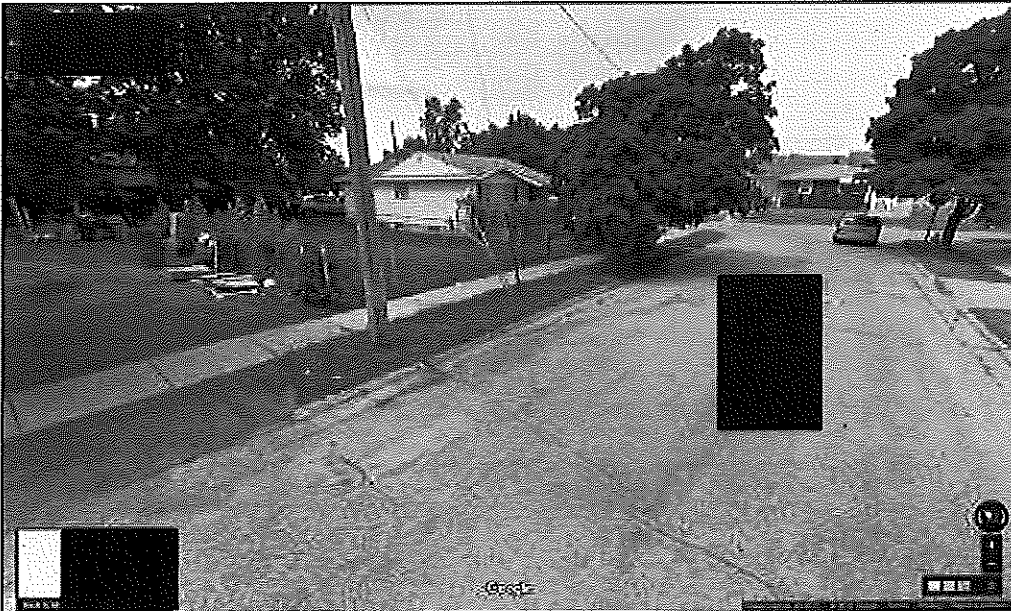
July 2011 image [REDACTED] (view from [REDACTED] toward Bryant Street).

Google 'Street View' Image 1 captured in July 2011 shows no patches in street along curb next to the parkway where the [REDACTED] service line runs toward Bryant Street, indicating that the physical disturbances occurred after the date this image was captured (July 2011).

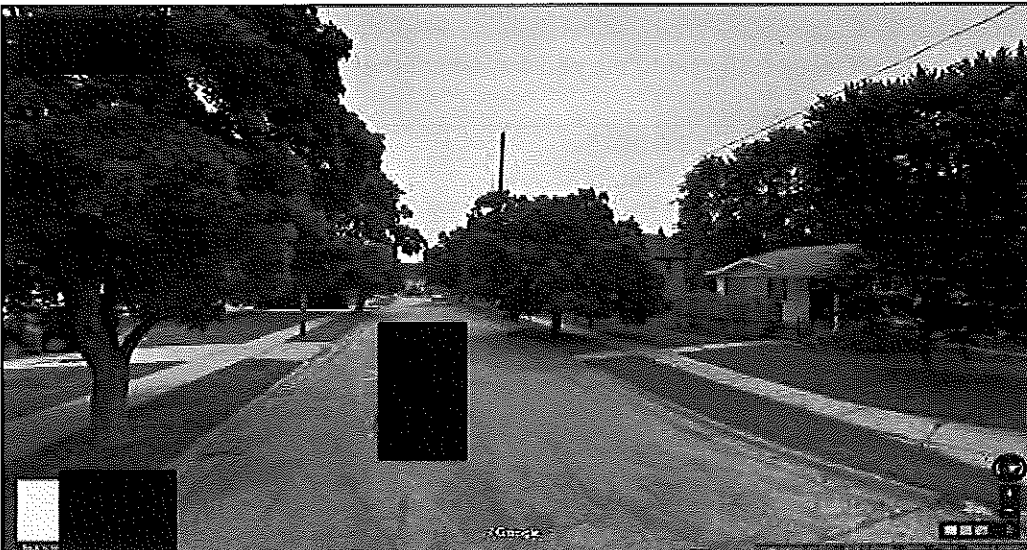
July 2011 image of [REDACTED] (view from Bryant Street toward [REDACTED]).

Google 'Street View' Image 2 captured in July 2011 shows no patches in street along curb next to the parkway where the [REDACTED] service line runs toward Bryant Street, indicating that the physical disturbances occurred after the date this image was captured (July 2011).

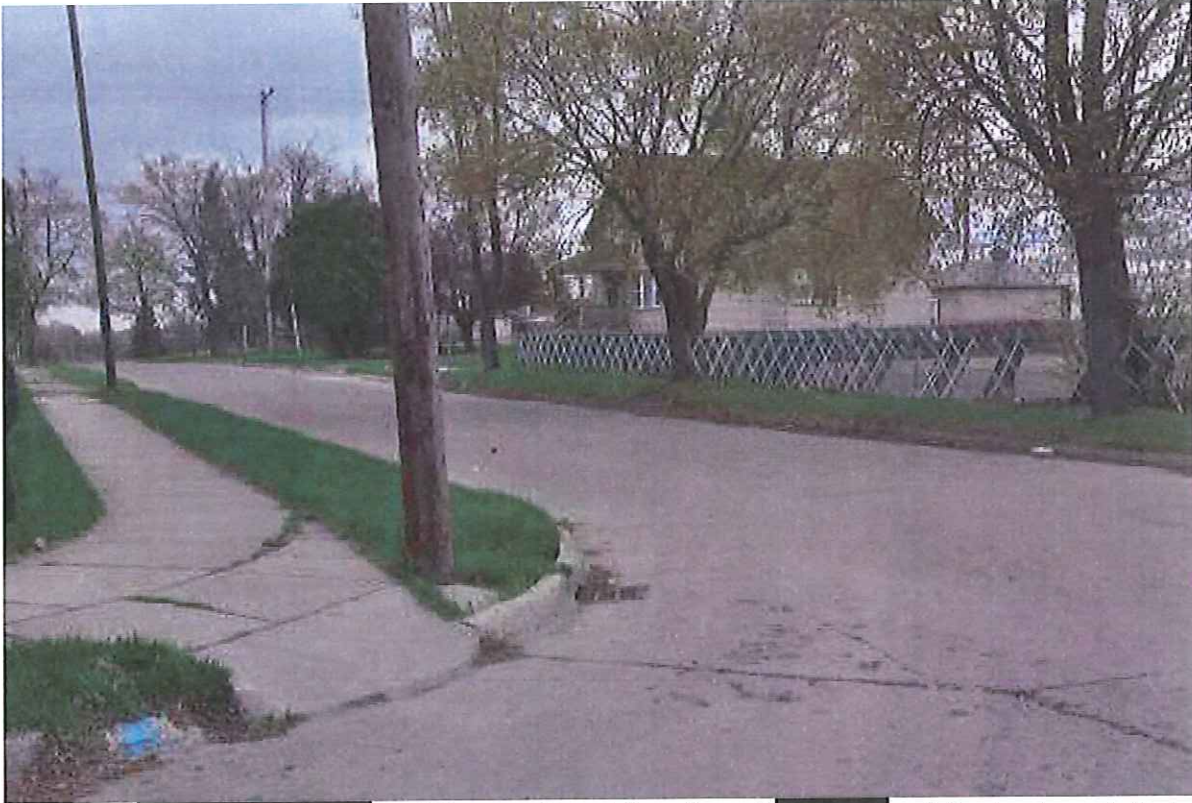
Corner of [REDACTED] and Bryant Street (location of [REDACTED] original external shut-off valve).

Photograph taken by EPA on April 27, 2015 shows no visible signs of physical disturbances in the vicinity of the lead portion of the [REDACTED] service line from the external shut-off valve to the water main on Bryant Street.
