June 19, 2014 Draft

Water Technology Project # 13399.01

Project Description: The Traverse City Water Feature was conceived as an interactive, educational water playground for citizens and visitors to downtown Traverse City, MI. Designed and constructed during 2012/2013, the Water Feature is located in Clinch Park, a waterfront park in downtown Traverse City. Part of Clinch Park's bay front plan, the Water Feature work was part of a more general scope which included landscape areas, a concessions & bathhouse building, an accessible kayak launch, a playground, walkways, decks and civil improvements. The intent of the Water Feature is to provide an inter-active, educational water feature for the public to play in. (Photo 01) The design of the Water Feature is intended to emulate the natural water cycle. (Photo 02)

Draft 6/19/14
Clinch Park

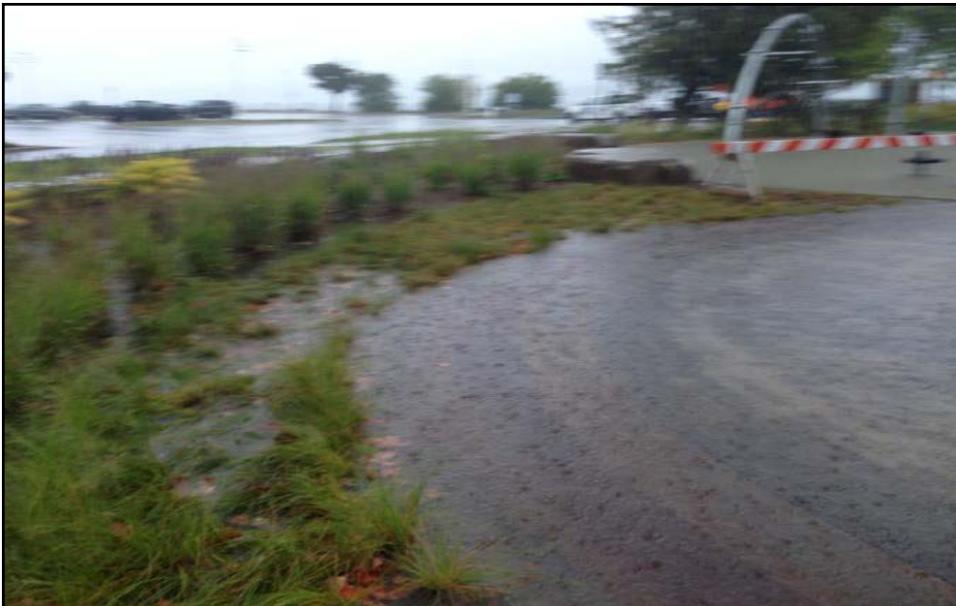
Photo 04

- 1. The Water Feature area and pad floods in moderate to heavy rains:** The Water Feature is located adjacent to the Traverse City Marina, near a parking lot and kayak launch at the edge of West Grand Traverse Bay. The site is relatively flat, with grades on drawing C6.4 ranging from 583.80 to 587.30. The rim elevation of the Water Feature is generally 584.0, placing it at a lower point on the site (Photo 03). Site grading generally slopes towards the Water Feature, including paved walkways. The grading plan indicates the site sloping to the North and East, the sidewalk has an edge along its east side, sloping towards the Water Feature, a landscape berm and seat wall trap run off water onto the

Water Feature along the north side (Photo 04). There are no provisions to shed site water away from the Water Feature and it's immediate surroundings

The location and grade elevation selection of the Water Feature does not meet MDEQ code requirements:

The Water Feature's site location, grade elevation and detailing do not meet the code requirements. During rain events, city staff stated that leaves, grass clippings, mulch and other debris flood onto the surface of the Water Feature and into its circulation system.

The best way to mitigate the flooding and debris to the system is to prevent its entry on the Water Feature in the first place. Options to accomplish this include:

- Developing landscape berms to direct site watershed around and away from the Water Feature.
- Installing trench drains along walks to collect and remove the water sheeting across the walks and decks. These drains would require a piping system to remove the water to a suitable location.

- Develop a drainage "barrier" around the spray pad. This would include a walk way of approximately 4' minimum, sloped away from the pad, around the Water Feature. Loose rocks in the landscape area would be grouted in, the center landscape area would be lowered and provided with a landscape area drain, piped to a suitable location. Increasing the apron size would provide the additional benefit of area for observers and other activities such as stroller parking.

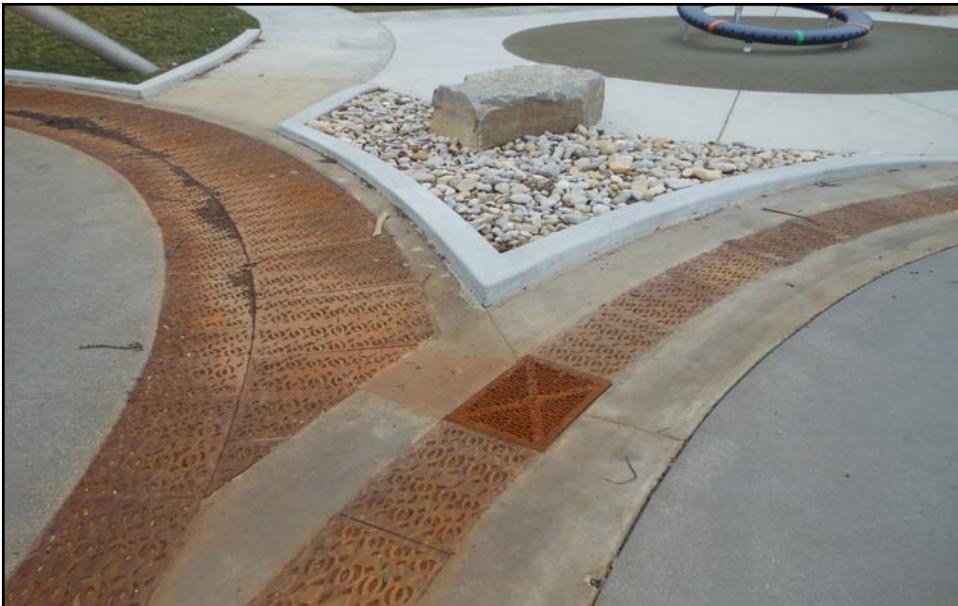
Photo 06

2. Concrete curbs were added to select locations to contain and direct the water flow, in lieu of the domed finish surface described in 1/C8.4:

Approximately 45 LF of 6" x 8" concrete curb was installed at the east and west

junctions of the water feature runnels (troughs)(Photo 06). It was represented by city staff that the curb was installed at the recommendation of Hamilton Anderson in “trade” for the domed finish which consisted of 12 each 4’ radius rebar circles and 17 each 4’ partial rebar circles embedded into the domed surface. A circular pattern is also indicated on the drawing, but not described. A Change Order, Change Directive or Work Order adjusting the contract terms was not included in the documentation provided.

Recommendations: The curbs should be reviewed and leading edges and sharp protrusions should be ground down. A better detail would have been a curb flush with the Water Feature’s edge, tapering to provide a curb away from the play area. The City should reconcile values for work traded.

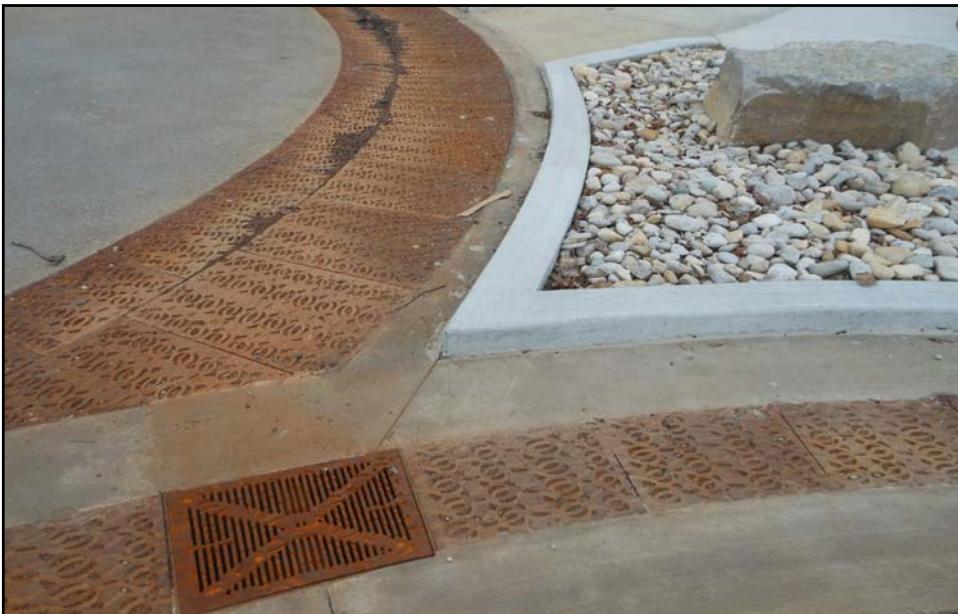
Photo 07

Comments: The concrete curbs, as installed, present a safety concern in the form of trip and fall hazard and sharp corners (Photo 07). The domed surface described in the contract documents is extremely intricate and labor intensive, if the “trade” for the curbs is what happened, the city did not receive an equal value in this trade.

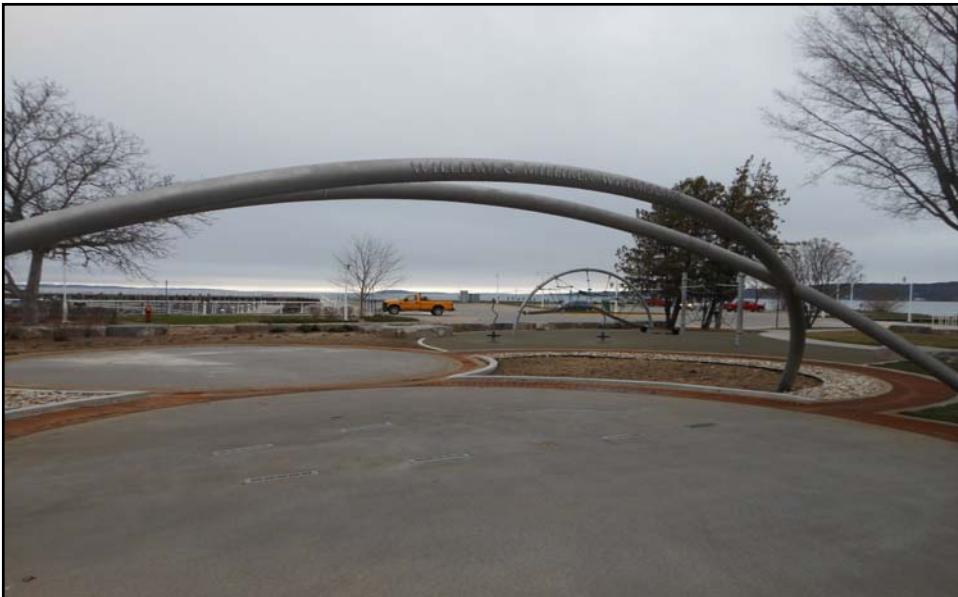
Photo 08

3. **The domed surface is slippery when wet.** The domed surface is described on C8.4 as an 8” shotcrete domed surface (Photo 08). As mentioned previously, #4 reinforcing (1/2” bars) were intended to be installed in circles; the reinforcing “stamped ½ of bar diameter (1/4”) into shotcrete.” There are also series of concentric circles shown on the drawing, these circles are not defined. The Project Manual lists two concrete sections in the specifications, 033000 Cast In Place Concrete and 033713 Shotcrete. Section 033000, part 3.8 B. requires a float finish, further describing the finish as “..left with a uniform, smooth, granular texture.” Section 033713, part 3.8 C.1. describes a medium sandblast finish, 3.8 C.2. requires that the contractor verify the finish suitability with a mockup. This section further requires “concrete sidewalk with sandblast finish to meet minimum ADA coefficient of friction requirements. 0.6 minimum.”

Comments: The domed surface, based upon its intended use, should be a non-slip surface. The drawings do not describe the concrete finish on the dome. There is no note on the drawings referencing “non-slip” or providing a non-slip criteria. The connective circles shown may have been etched rings or ridges, but are not detailed. The reinforcing steel embedment may have helped, but were not installed. The detailing of the embedded reinforcing steel is not clear; two issues which would have arisen include the circles not conforming to the curve of the dome, and how to resolve the intersections of the reinforcing circles. Another

issue with this detail would have occurred later, as the reinforcing bars rusted and expanded, damaging the adjacent concrete.

Recommendations: The domed surface can be acid etched or sand blasted to provide a non-slip surface. Water Technology, Inc. recommends that a small test area be used to establish how aggressive the surface needs to be. Care should be taken to protect the grating, which may be affected by the acid wash method.

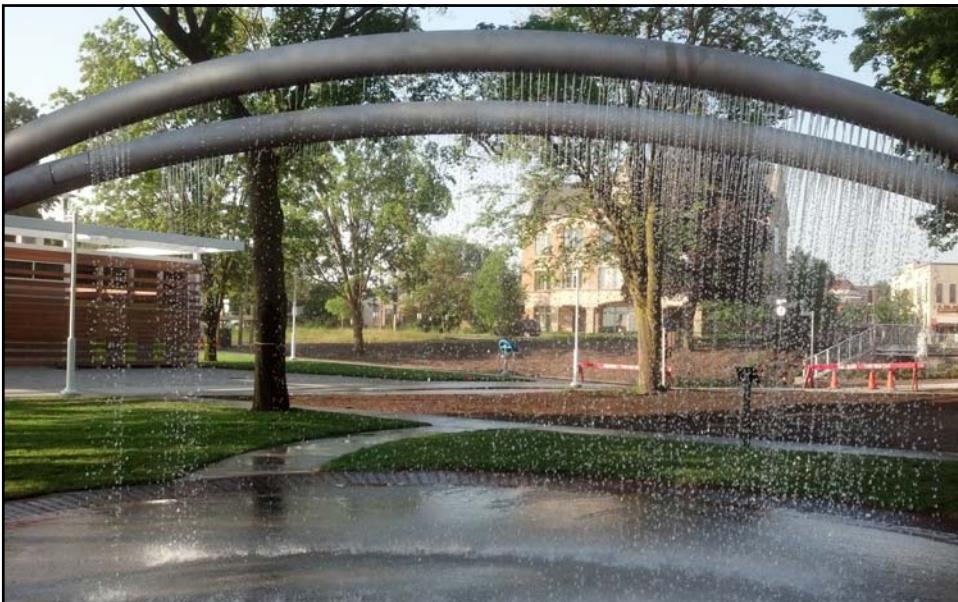
Photo 09

4. **The “Arched Rain Bar” feature does not work properly.** The feature is intended to provide two 17' -0" long curtains of water in a rain like effect. The water is to fall onto the dome and wash down the surface to the perimeter surface grating. When started, the Arched Rain Bar (ARB) created the effect unequally, showering one end of the bar, leaving approximately 1/2 of the dome with little water effect (Photo 09).

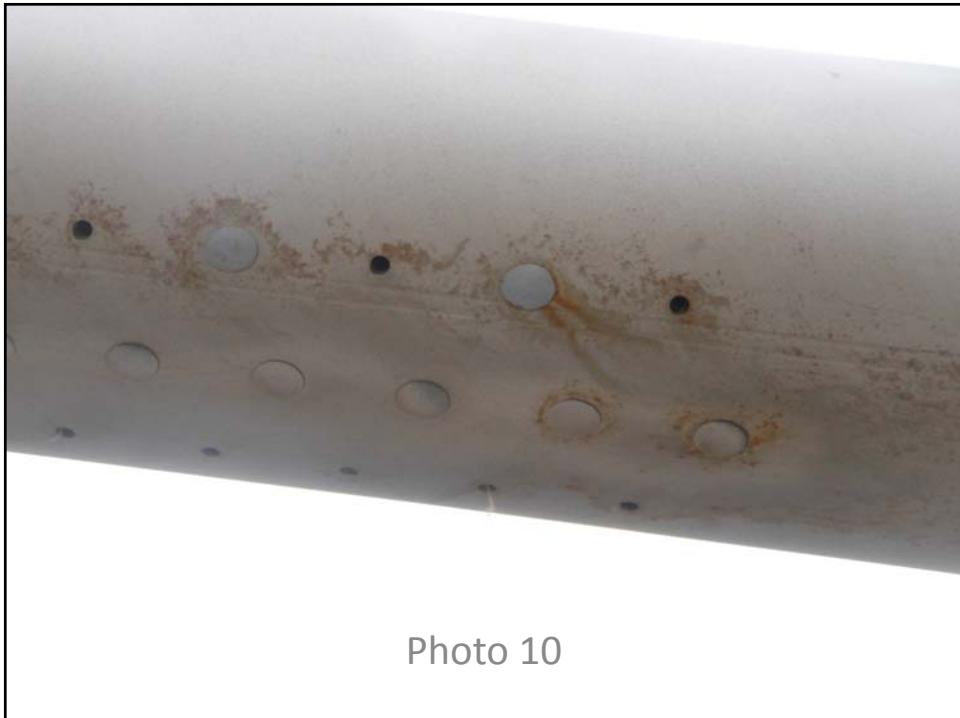
Photo 10

Comments: The Arched Rain Bar feature, as conceived and detailed could not create the effect intended. The ARB consists of two intersecting 8" pipe arcs, with 315 ea. $\frac{1}{4}$ " holes drilled into the underside of each arched pipe. The intended effect was that of rain falling across the 17' – 0" span of the area with the holes drilled (see 8/C8.4). The feature's water supply is from one side and consists of a single 4" pipe connected to the ARB manifold (P2, ME1, and W1.1). Drawing P2 defines the pipe size as 4", drawing ME1 routes the pipe to one end of the feature, drawing W1.1 shows the 4" pipe splitting into two 3" feeds. Drawing C8.4 requires baffled ends, a detail shows a 3" threaded pipe coupling at baffled ends, a leader line for this note goes to one end. A simple calculation reveals that the number of $\frac{1}{4}$ " holes equals 30.92 in^2 of open area. A 4" pipe has 12.73 in^2 of open area. This in-balance results in the feature having water at one end, and being starved at the other end. According to Staff, the Aquatic's subcontractor, "Lightning Turtle" has plugged some of the $\frac{1}{4}$ " openings (Photo 10), in order to get the feature working.

Recommendations: The Contractor has attempted to balance the feature and create the effect intended by plugging approximately one half of the opening with plastic plugs (Photo 10). This strategy has proven somewhat successful. Reducing the open area of the feature will allow the feature pipe to “fill”, and create the effect intended. The balance of the feature in this manner will be by trial and error. Water Technology, Inc. recommends plugging approximately 2/3 of the holes of the first third of the supply side of the feature, the middle row of the center third of the feature, and every other hole the downslope third of the feature as an initial balance point. A second solution would be to add an additional water supply, symmetrical to the first to balance the supply. It should be noted that this second supply would over-take the existing feature pumps, piping and reservoir capacity. The additional water supply (4") is not sufficient to balance the open area of the holes, but would significantly reduce the imbalance. A third option would be to plug all of the openings, and provide new openings in a level plane along the sides of the pipes. Thus the feature pipe would “fill” to an equal point, and then spill equally across the openings. A fourth option would be to tap the openings, and replace with a threaded 1/4" reducer, reducing the hole size to 1/8".

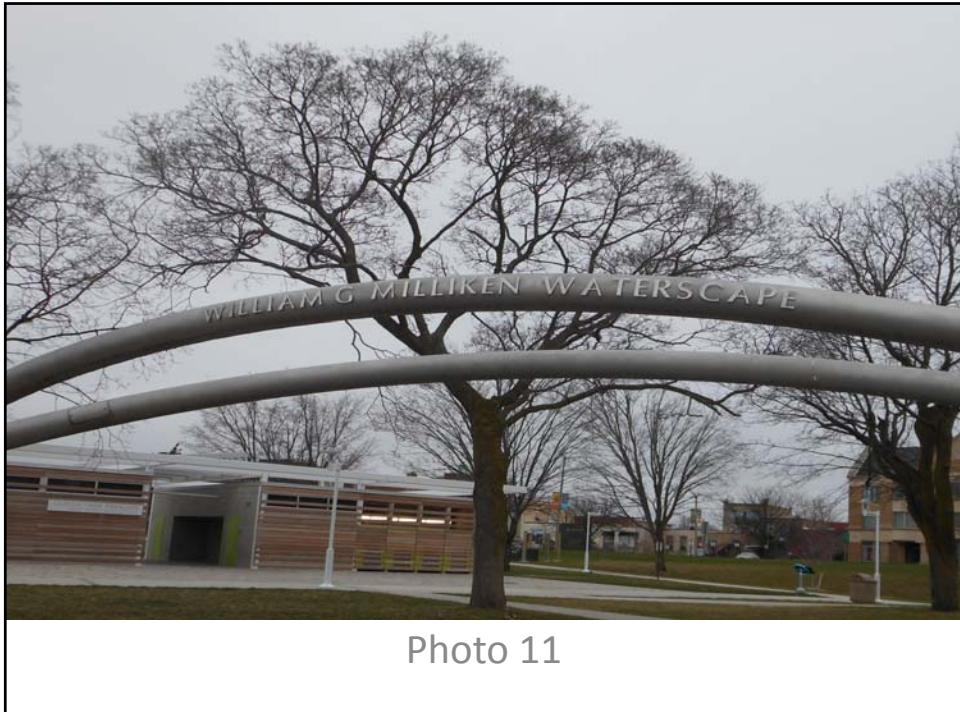
Photo 11

There is no finish specified for this feature. The combination of the low arc of the arch, the fact that it springs from grade, and the surface roughness of the piping make the feature an attractive challenge to climb. Staff reported seeing parents assisting their children in starting to climb the feature. The feature’s maximum height of 10' above the concrete surface makes a fall a serious issue. The

lettering which is welded to the piping poses both a cut and strangulation hazard (Photo 11). Additionally, the feature low arc leaves very little headroom at the perimeter of the dome where the arches rest. At the outside edge of the dome, the clearance is about 24". A clear headroom of 7' – 0" is not met until 7' inside of the edge of the dome play area.

Recommendations: Due to the obvious nature of the hazards presented by the feature, Water Technology, Inc. recommends immediately placing signage at the feature stating "No Climbing" & "Fall Hazard". The feature should also be reviewed by the City's risk management and insurance administrators. The following recommendations should also be reviewed by these risk management personnel prior to implementation.

- A) Paint the ARB with a gloss finish, making it slippery and less likely to be climbed. The finish will have the added benefit of protecting the steel. Additionally, if some of the holes are to be permanently filled (see #4 above), the paint finish will reduce the visual impact.

- B) Remove the lettering, replace with lettering that is flush with pipe surface.
 - C) Protect area under rain arches to reduce head clearance issues. Options include barriers, large rocks (although these likely will still be climbed) an un-walkable surface (such as grouted stones) or surface warnings.

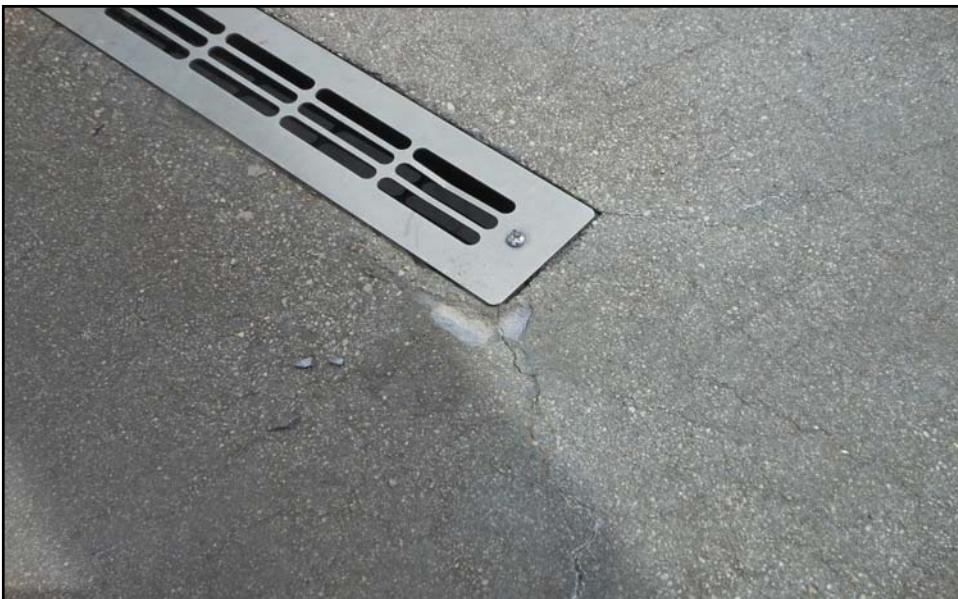
Photo 12

Comments: Staff reported three concerns with the lighting: sharp edges of the slots in the "rock guard" cover (Photo 12), heat of the fixture and cover when in operation, and the winterization of the fixture, which requires disconnecting the wire junction for each light and re-wiring every spring. The sharp edges of the rock cover were also noted by the inspecting MDEQ official (see MDEQ Report of 08/27/13, item 17./12.), requiring staff to install a plexi- glass plate between the rock guard and the fixture(Photo 13). This has the added benefit of preventing water and debris from collecting in this void. It is unclear form the manufactures literature if the fixture is intended for use as a "dry" fixture. Winterization instruction prepared by The Fountain People (O&M P12732) states, under the heading "Winterizing Niche Type Underwater Light Fixtures" to "disconnect wire connections". The O & M manual also states that "Only persons qualified and

authorized should be allowed to operate or maintain this electrical equipment," placing an operational burden on the City.

Recommendations: Staff's action of installing plastic guards has mitigated an obvious concern. The City should contact the manufacturer to establish if this installation impacts the fixture's operation or warranty in any way. If concerns are expressed by the manufacturer, an alternate cover should be requested. During the next operating season, the City should also measure the surface temperature of the stainless guard to establish if operating with the lights is feasible. It is also recommended that the City investigate the potential of installing waterproof plugs on the fixtures to simplify winterization. It should be noted that the current LED-180N offered on The Fountain People's website is equipped with an IP68 waterproof connector. The addition of a waterproof connector may be done by a local electrician, or by returning the fixture to the manufacturer. If this installation is contemplated, developing a test cable with the plug is suggested, so that it can be established that the plug can make the pulls in the spring. Another option may be to pull the wire and have the plugs field installed at the niche location. This should be verified with the manufacturer and against code requirements. Alternate solutions would be to abandon the in deck lighting and develop an alternate lighting plan, or to abandon lighting the feature.

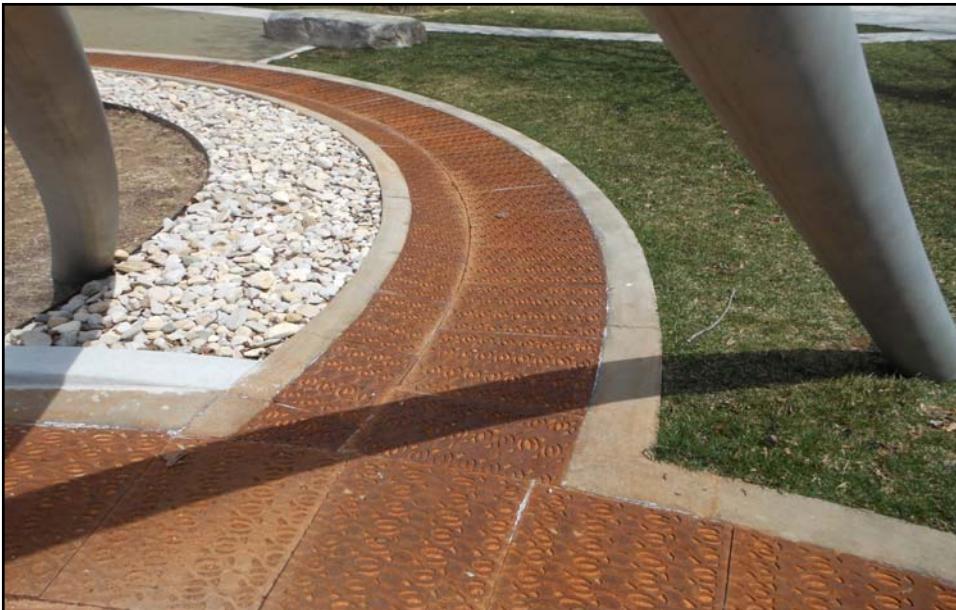
Photo 14

7. The perimeter stream trough does not flow properly, has areas that pond water, and traps debris.

The perimeter stream trough is made up of iron gates with a decorative pattern(Photo 14). Specified in the project manual as "Water Weir Trough" by West Gate Sheet Metal, the installed product has an IRON AGE stamp, it is presumed that the grates were manufactured by IRON AGE DESIGNS of Burien, WA(Photo 15). This was confirmed with a search of the IRON AGE WEBSITE, which contained a drawing labeled "Clinch Park".

Recommendations: The combination of low slope with a patterned corrugated surface, makes the trapping of debris and ponding areas likely. Corrective actions could include: replacement of the cast plates with a smoother gutter trough material; "filling" portions of the voids in the pattern with a material to reduce the voids while leaving the top of the pattern intact. Another potential solution would be to introduce additional water flow into the landscape channel. Increasing the water in this channel will increase its flow reducing the likelihood of stagnation. The ponding area in this channel should be corrected.

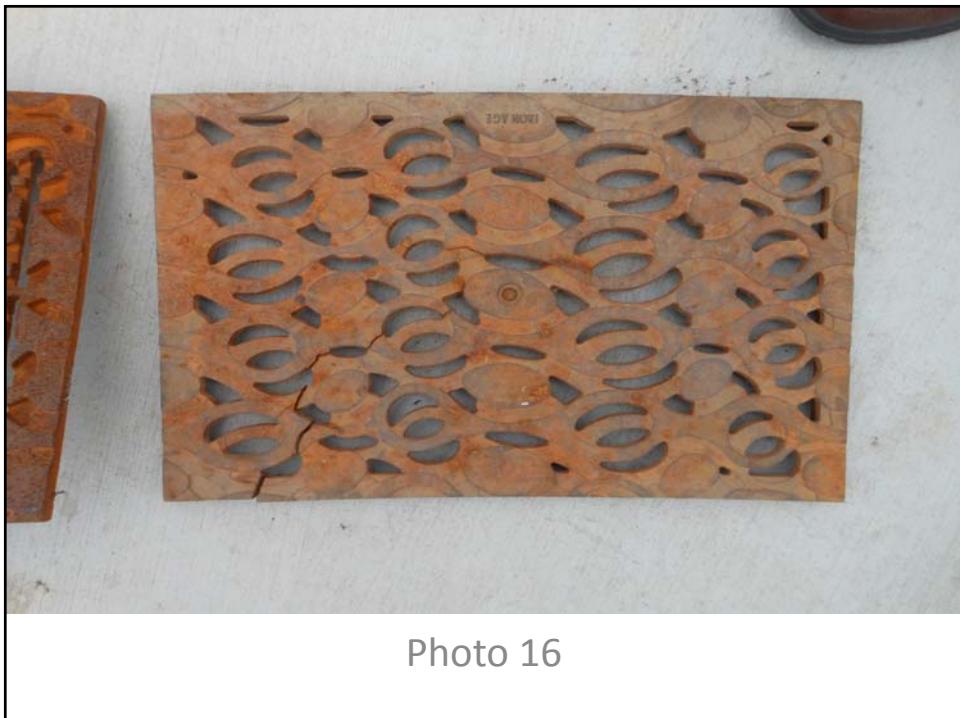
Comments: The perimeter stream trough is intended to imitate a stream, with water running along the stream, conveyed by the trough to the eight drains located at the perimeter of the Water Feature area. The trough is made up of a series of cast iron "gutter" plates (See 2-7/C8.4). The gutter plates are a custom fabrication from IRON AGE, as the website describes the product as their Janis radial trench grating, 1" thick, with no openings greater than $\frac{1}{2}$ ". The gutter is made up of grating of this pattern without any openings. This grating (with openings) was originally installed over the drain locations, staff reported that

there was inadequate open area, causing flooding of the Water Feature (Photo 16). Staff replaced the grating with plastic for the initial season and made custom grates from the gutter product for the next season(Photos 17 & 18). The gutter material's pattern and fabrication result in it having depressions which trap debris and water. Drawing C6.4 documents the slope of the gutter, which has a high point of 584.79 to a low point of 584.0 (a 1.48% slope) for the dome area gutter. The gutter around the landscape area falls .64', providing a 1.25% slope. There is ponding water in two areas of the trench(Photo 19). The reduced slope around the landscape area, combined with its longer run, means very little water will run in this portion of the gutter (Photo 20). The reduced water flow, with a very shallow slope and a gutter material likely to trap debris and water makes ponding almost inevitable. With the amount of landscaping and vegetation immediately adjacent to the water feature, organics are likely to be trapped in the ponding areas, providing opportunity for bacteria growth.

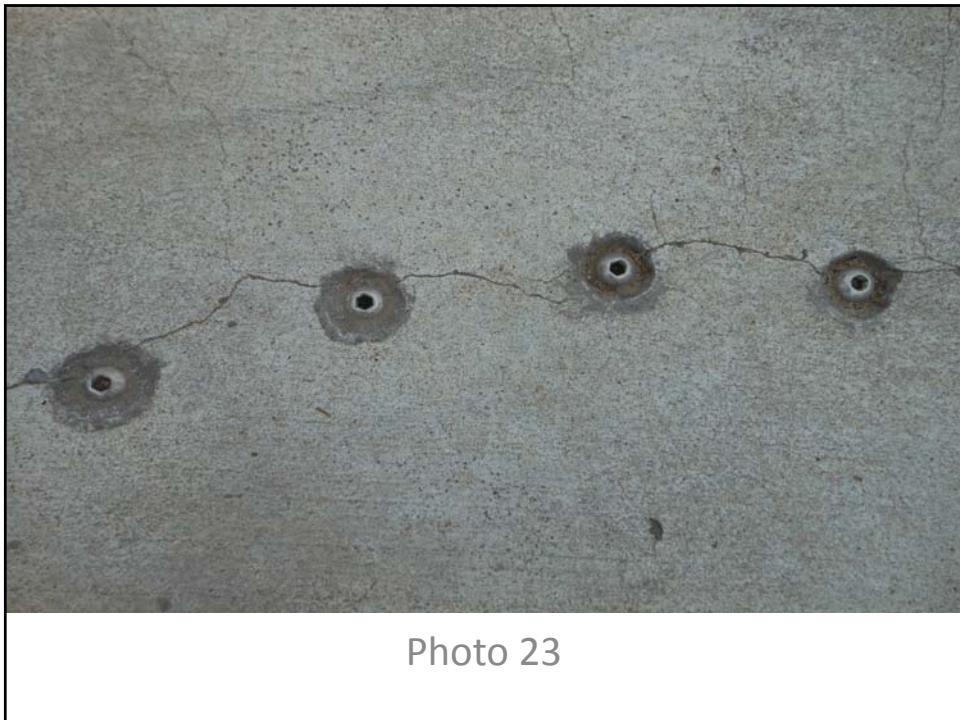
Photo 23

Comments: The “water cage” or spray ring feature appears to be a fountain product adapted to an interactive spray pad. The product cut sheet shows the product installed in water, the manifold ring is shallow for a concrete installation. Detailing the installation with a control joint connecting the nozzles would have helped. Staff noted that winterization of the feature involves removing the 210 “nozzles” from the feature and replacing them with plugs. Staff further stated that some of the nozzles are very difficult to remove, as the threading of the “nozzle” goes through concrete(Photo 23).

Recommendations: Essentially this condition is the result of the wrong application of a product intended for another use. Given the project's shallow depth to the manifold and the limited spacing between nozzles, the concrete deterioration is not surprising. Winterization difficulties also highlight the fact that the product is not designed for this application. Corrective actions include removal of concrete around the rings and replacing with a joint between nozzles, re-furbishing the spray rings with a bushing that would be flush to the concrete finish, but recesses the nozzles, or placing a safety surface over the splash area of the feature to cover the concrete.

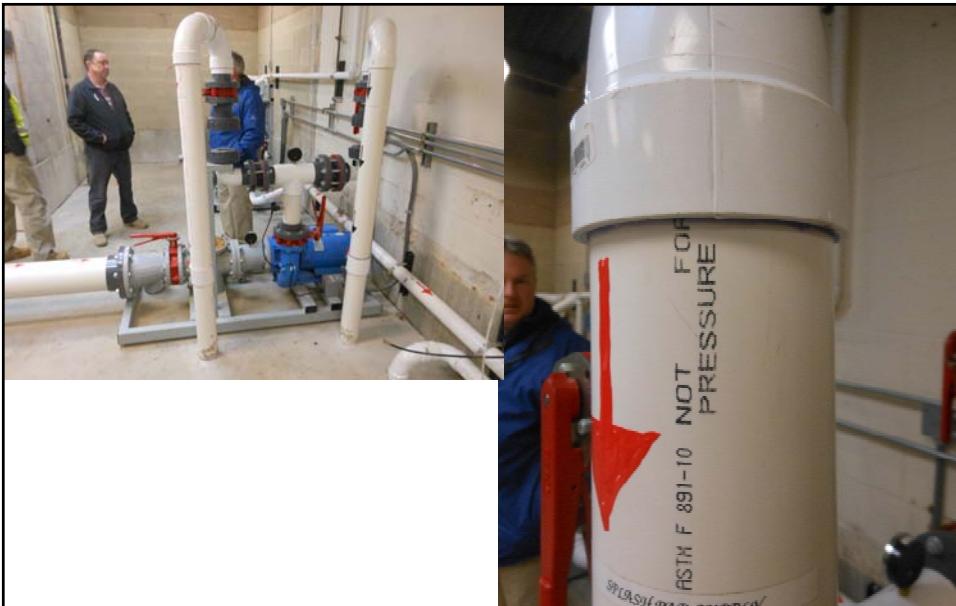
Photo 26

- 12. Installed piping is not code compliant.** MDEQ requirements state that piping is all able to withstand operating pressures of 160 pounds per square inch. Exposed feature piping in the mechanical room is labeled "Not pressure rated" (Photo 26).

Comments: MDEQ (R325.2137) (1)(E) requires that " all pool water piping is of the following. (e) rated to withstand operating pressures of not less than 160 pounds per square inch"

Project specifications do not establish requirements for feature piping. Section 131500 lists applicable codes and standards, but does not include MDEQ'S code in this list. Plumbing specifications do not reference PVC pipe standards, nor does the water feature piping under products. Neither section requested submittals on water feature piping and valves. Water feature general notes, found on sheet W1.1, does state that the installation shall comply with local plumbing codes (Note 1), and that interconnecting pipe and fittings "Shall be of copper, minimum schedule 40 PVC, stainless steel or fiberglass" (Note 4). Again these notes do not address or necessarily meet MDEQ requirements. This issue was addressed during the permit review process, cited in MDEQ's letter to Mr. Davis (Issue #6 of the 7/22/13 letter). The response from David Graves, PE states that "Schedule 40 pipe used was specified, and used for the work has a rating higher than 160 psi". While it is impossible to know what each installed pipe is, some exposed piping in the mechanical room bears a manufactures label "Non-Pressure Rated." This piping in the feature's mechanical room does not meet code requirements.

Recommendation: Excavate and evaluate piping, replace non-compliant piping.

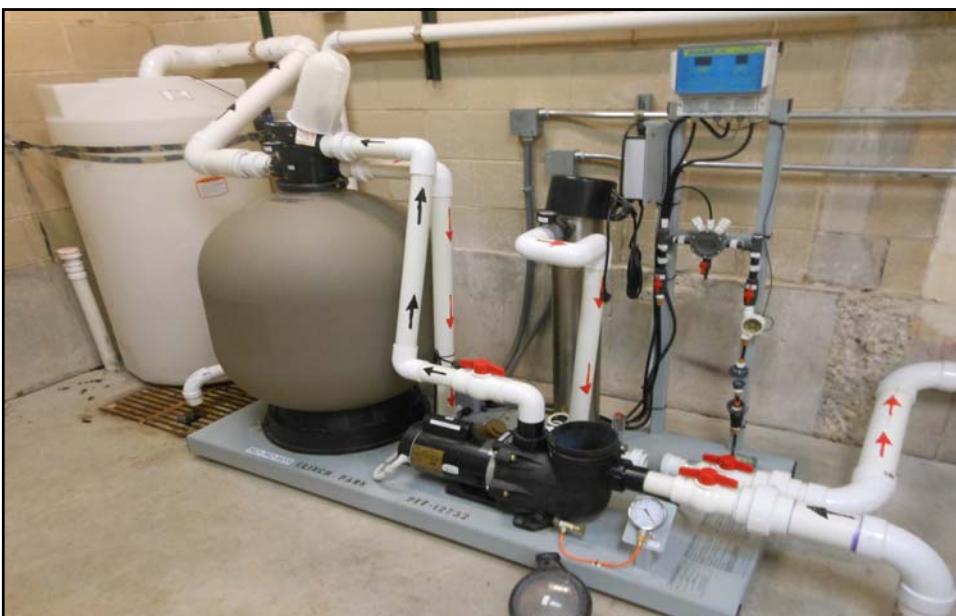
Photo 27

- 13. The filtration seems undersized, requiring backwash of system every ½ hour on busy days.** Staff reported that during hot days the feature must be backwashed frequently. Backwash water is sent to a 150 gallon holding tank which acts as a retention basin, releasing water at a metered rate through a 1.5" pipe (Photo 27). Backwashing frequencies of every ½ hour were reported.

Comments: The filtration loop consists of the filter pump, a filter, Ultra Violet (UV) treatment and chemical treatment. Specific equipment includes:

MDEQ does not specifically address interactive water playgrounds such as the Clinch Park water feature. The closest MDEQ comes to addressing this type of feature is requiring a 1 hour turnover for a wading pool. Review of adjacent Mid-Western state codes provides the following:

Recommendations: At a Minimum, the addition of a second filter of equal filter area to the existing is recommended. If other recommendations are implemented, (Specifically pipe replacement) Increasing the filtration to the MAHC standard is advisable along with the addition of two S360T2 filters, with 7.06 SQFT of filter area each. An alternative solution, worth considering in conjunction with #10 and #11 previous, would be to replace the existing filtration system with a combination reservoir/vacuum sand system. An engineering analysis of the cost of this system to a "parts" replacement method is recommended to evaluate the costs and benefits. Replacing the UV with a properly sized unit is also recommended.

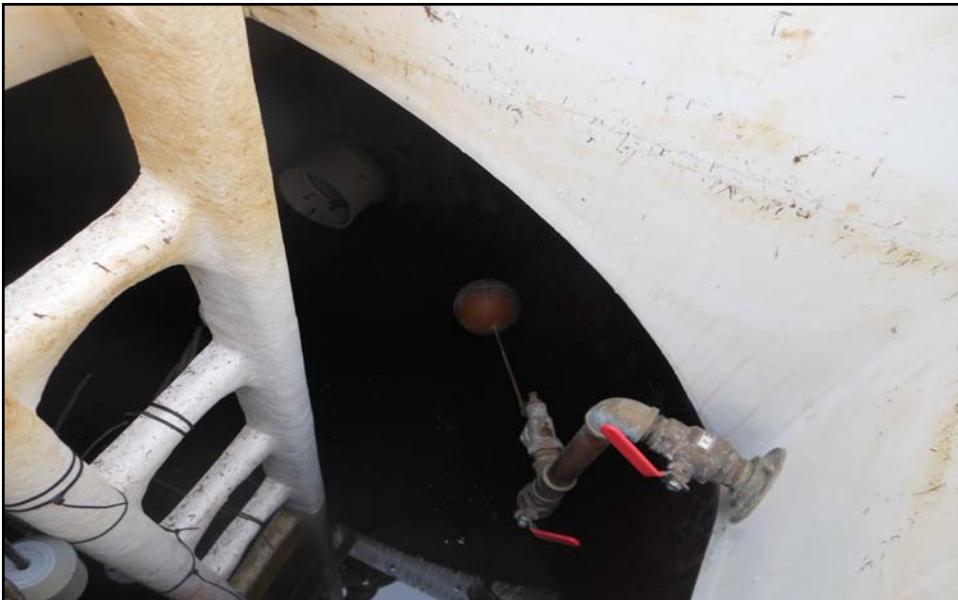
Photo 28

- 14. The auto-fill for the water feature is difficult to monitor and repair.** The water features auto fill consists of an 18" rod and float valve located in the reservoir tank (Photo 28). The MDEQ code requirement (R325.2126(b)) for a backflow device is provided in the mechanical room with a backflow preventer.

Comments: The only contract references to the auto-fill are found in the specifications (131500-2.3 C.7), which references a "mechanical water fill system w/quick fill valve" under part FWR-12732, 2000 reservoir system. In order to repair this valve, or utilize the "quick fill" valve, staff must enter the tank through the hatch and ladder, requiring staff to follow OSHA confined space procedures. There is no way to monitor the tank level without opening the tank. See also issue #10 above.

Recommendations: During design, a simple solution would have been to route two PVC lines to the mechanical room (1 for fill, one stilling) and placed the auto fill with an air gap in this room. This would have eliminated the need for a backflow preventer (and its yearly maintenance) and confined space entry. It is

WTI's recommendation that the auto-fill be re-located, specifically in conjunction with #'s 10, 11 mentioned previously.
