**MITCHELL PARK HORTICULTURAL CONSERVATORY
DOMES
Peer Review**

Milwaukee, Wisconsin

Final Report

WJE No. 2016.2700

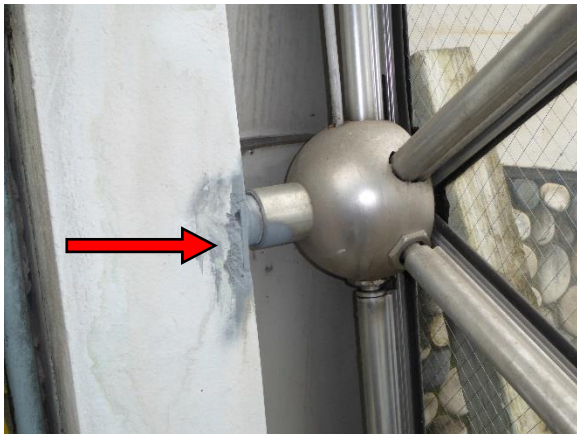
3. Concrete spalls had been removed at several embedded connections where the hub from the glass cladding is supported by the precast framing (Figures 14 and 15). The embedded plate was painted at the location of removed spalls.

Figure 14. Removed spall at connection location. Note: connection is painted with blue colored coating.

Figure 15. Removed spall at connection location. Note: connection is painted with blue colored coating.

Based on our walk-through observations and review of previous GRAEF reports, the precast concrete framing appears to be in fair condition and consistent with long-term exposure to moisture and the environments within the domes. The primary issue is spalling concrete at the embedded connections, which appears to be the result of shallow concrete cover, corrosion of embedded plates, and cyclic temperature changes. Shallow concrete cover on the sides of the embedded plates makes the concrete susceptible to spalling as originally designed. The greatest amount of spalling was observed in the Desert Dome. We would expect the humidity level to be the least in the Desert Dome, which may indicate that the humidity level is not a significant factor in causing corrosion at embedded plates and subsequent concrete spalling.

The spalling hazard can be eliminated by removing the concrete cover at embedded plates. Installation of the netting system has mitigated concerns with spalling concrete. Corrosion at embedded plates will continue if ongoing water leakage is not resolved. We would anticipate that the amount of spalling concrete will decrease as water infiltration is minimized and a higher percentage of spalls are removed at connection plates. Concrete deterioration within the main body of the concrete member has only been an issue at a few locations with minimal concrete cover over reinforcing bars. However, continued exposure to moisture with a failed coating system can lead to additional deterioration of the concrete if not addressed.

1. Remove delaminated concrete at embedded plates, and clean and paint the plates. Proactively removing potential spalls at connection plates could be performed, but may not be necessary if the netting remains in place. If removing the netting is desirable, we recommend proactively removing potential spalls at embedded connections.
2. Repair concrete spalls with exposed reinforcing steel within the body of the precast member.
3. Repair deteriorated areas of grout.
4. Clean and paint the concrete with a coating system capable of bridging over cracks. Some cracks and joints may need to be stripe coated or sealed prior to the coating installation.

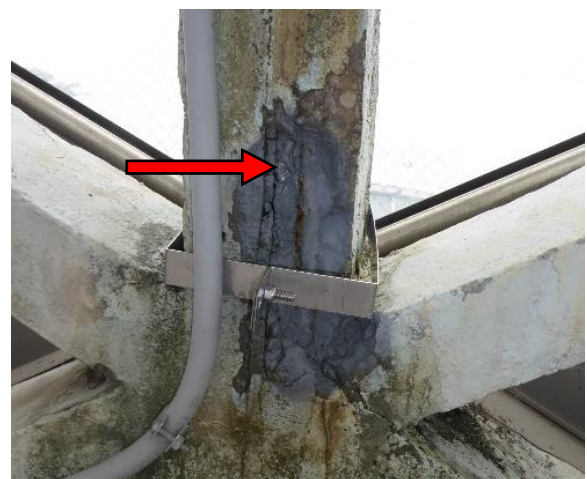
4. Concrete spalls, previously removed, were observed within the body of the precast concrete member, exposing reinforcing steel at a few locations in the Arid Dome (Figures 16 and 17). The reinforcing steel appeared to have minimal concrete cover.

5. Missing grout was observed between precast members at a few locations (Figure 17).
6. Fine, transverse-oriented cracks spaced along the length of the precast members were observed at several locations (Figure 18). Cracks were typically highlighted by soiling and peeling paint.

Figure 17. Removed spall within the body of the precast element. Note missing grout between precast members.

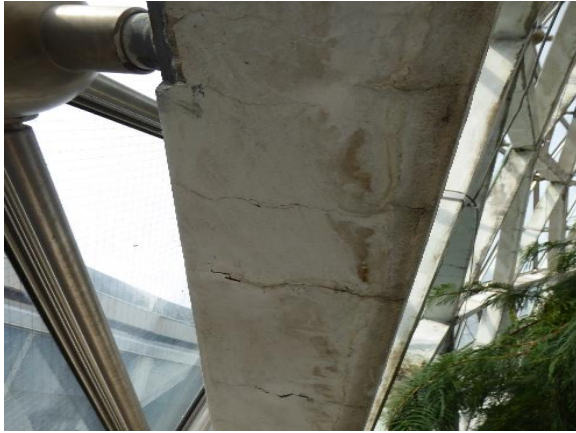
Figure 18. Transverse cracks on precast member

The cracks observed on precast members are not an indication of any structural deficiency and appear to be the result of concrete shrinkage and stresses associated with normal structural behavior. In their current state, the cracks will continue to open and close with temperature change. The drying shrinkage in this concrete has mostly taken place and is not a factor to cause further cracking. The cracks should be protected from moisture. GRAEF reported cracks between precast members, and between the concrete base and precast members. We suspect that the cracks were observed in the coating system at the joint between precast members and between the concrete base and precast members. The joint should be sealed during the installation of the new coating system.

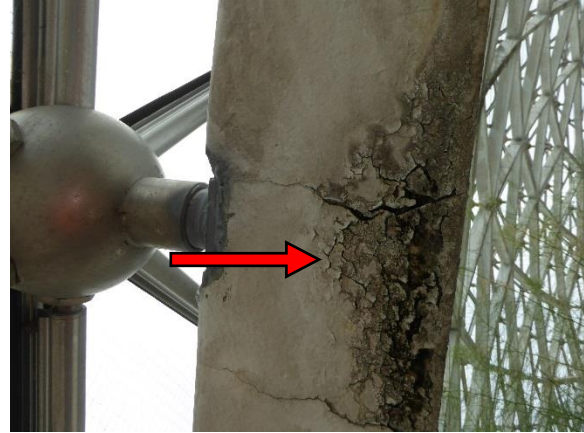
7. Cracked and peeling paint was observed on most precast members (Figure 19).

Figure 19. View of cracked and peeling coating on precast member

- We recommend that the following characteristics be considered with the selection of a coating system: concrete carbonation protection, waterproofing, and aesthetics. The recommended coating systems by GRAEF for the precast concrete include an epoxy system and a stain. The stain will not be able to bridge cracks in the concrete and we do not recommend that a stain be installed. We recommend that further research be performed by GRAEF to understand the crack bridging capabilities of the proposed epoxy system. An epoxy system may fade and degrade slowly due to ultraviolet exposure, but could be beneficial to seal the concrete from oxygen depending on future corrosion potential due to the existing concrete carbonation depth and operating environment. A breathable acrylic or acrylic elastomeric coating could also be considered for the precast concrete members. An elastomeric coating will provide good crack bridging capabilities, but may not bond well in a humid or damp environment. A different coating system could be considered for each dome depending on the interior environment. Surface preparation and removal of the existing coating system may prove very difficult due to access and protection. Therefore, we recommend trial installations, bond testing, and evaluation of different coating systems and surface preparation techniques.

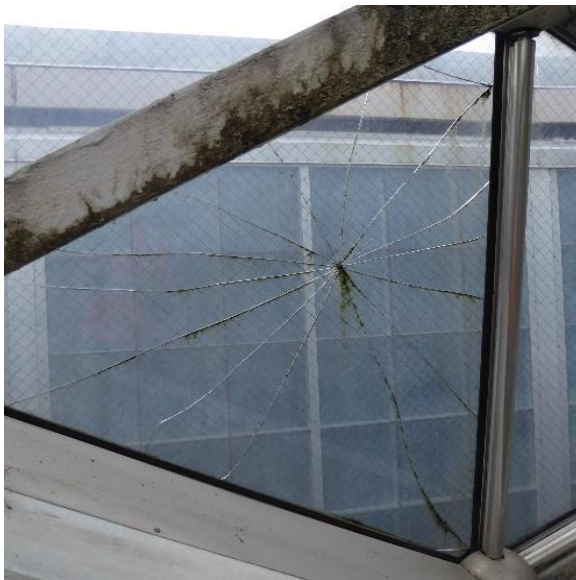
1. Cracked glass units were observed at several locations (Figures 20 and 21). Some of the cracked glass appears to be the result of impact.
2. The glazing material that separates the glass from the pressure caps has deteriorated over time. This is a likely source of water infiltration into the domes (Figure 22).
3. Sealant was installed around the hubs at several locations at the base of the domes (Figure 23).
4. Leakage was observed at approximately six locations in the Arid Dome at the connection of the hub to the downspout rafter. At locations where leaks were observed, the downspout rafter fitting had visible black material build-up, which seems to be an indicator of a leak location (Figure 24).

Figure 20. Cracked glass, likely from impact

The primary issues with the cladding appears to be glass breakage and water infiltration. Some glass breakage appears to be related to impact while other locations may be related to thermal movements. The glass is wire reinforced. If broken, wire reinforced glass is not normally considered a falling hazard, since the wires engage the broken glass and inhibit broken glass pieces from falling. The glass framing has a drainage system that collects incidental water, either due to occasional rainwater leaks or internal condensation. GRAEF had indicated that water was observed sitting in the hub and not allowed to drain, which is likely the reason why water currently leaks out at the hub locations. In WJE's opinion, this condition is a result of the original design of the drainage system which set the opening in the downspout rafter slightly higher than the hub. We believe that this condition can be repaired (see our following Recommendations section).

- The wired glass can remain as is, unless it is broken; in which case it should be removed and replaced. Full replacement of the wired glass is not required for safety reasons. At locations where the wired glass is broken, WJE recommends replacement in-kind or with laminated glass. Laminated glass will have a change to the cladding's appearance.

1. Replace existing cracked and broken wired glass in kind, or with laminated glass. Modifications in the glass replacement design could be implemented based on the findings from further investigation and mock-up repairs.
2. Remove and replace all pressure caps and wet seal joints (Figure 25).
3. Clean hubs and install self-leveling sealant at leading hubs (Figure 26).

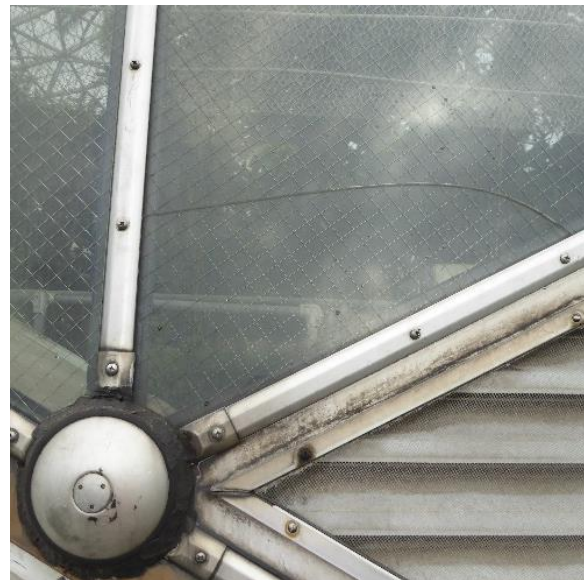
Figure 21. Cracked glass
