Very thin rotten ice and deep open water in the Gweek River below the 2nd bend from the mouth

3.29.19 BSAR River Report:*

"May in March"

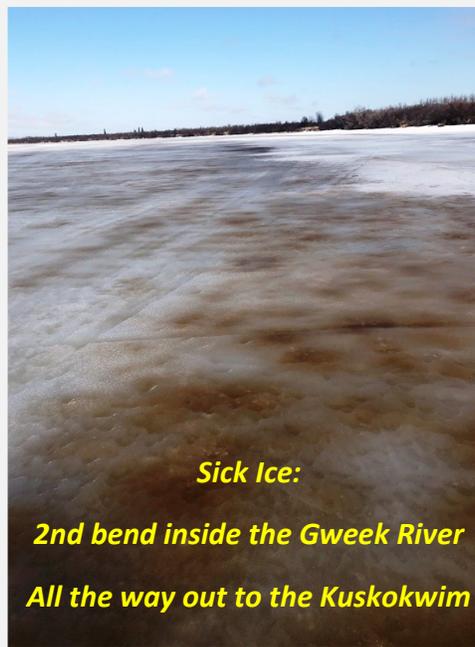
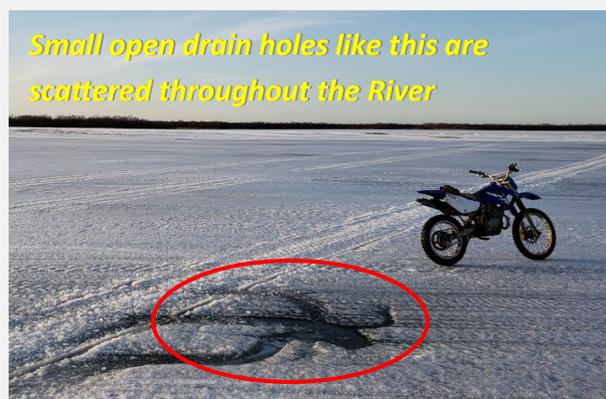
- **The Upper End of Straight Slough has gotten 5" thinner since Saturday. It is only 7" thick.**
- **All Ice that was drilled is SOFT**
- **The Gweek River ice is thin, rotten, and opening up from the second bend all the way out to the lower tip of the big (Pavilla's) island on the main Kuskokwim.**

- **The east side of the Kuskokwim below the Y and across from the upper end of Church Slough is only 4" to 6" thick. The ice however is deceiving—it looks white but is very thin and full of small open holes.**

- **Kuskokwak Slough above Kwethluk is only 6" - 8" thick through most of its length.**
- **The Akiachak Channel just above the Y has gotten 4" thinner since Saturday. It is only 8" thick in this area.**

- **The lower end of Church Slough below the little short cut slough is wide open with strong current**
- **Traveling near the beaches along the tide crack appeared to be safe but there are many small open drain holes along the crack.**

At tonight's meeting a local Elder reminded us that, "The trail you went out on in the morning will not be the same when you return later in the day". With River ice way below normal, conditions rapidly deteriorating and no cool weather in the short-term forecast this is especially true this year. We may be seeing things we haven't seen before. If you must travel do so with extreme caution.
