1996 TUMALT CREEK DEBRIS FLOWS AND DEBRIS AVALANCHES IN THE COLUMBIA RIVER GORGE EAST OF PORTLAND, OREGON

Sarah E. Johnson¹

ABSTRACT

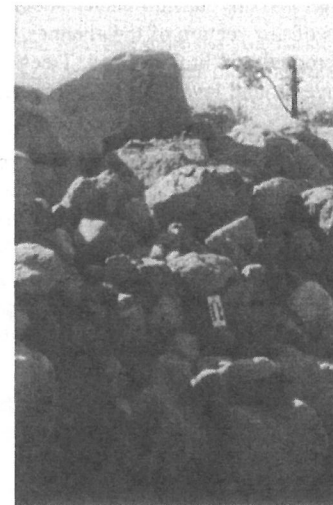
Figure 2a: Debris levee deposited by a debris avalanche, composed of andesite boulders, cobbles, and a thin coating of finer material.

Two distinct types of debris were deposited on the Tumalt Creek fan, and the debris flows that produced them seem to have behaved in strikingly different manners, though they both contained boulders up to 3 m in diameter. The early flows were very fast-moving and destructive. They knocked down acres of trees, and debarked and embedded gravel into the lower 2 to 4 meters of others. On the upper fan, the resulting deposits contain very little fine material (Figure 2a), and many of the boulders within the deposits are freshly fractured and abraded. On the

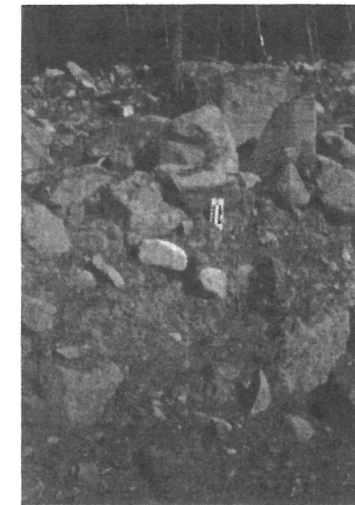
Figure 2b: Debris levee deposited by a muddy debris flow, composed of boulders, cobbles, and abundant finer material.

The later flows were not so destructive, moving more like wet concrete. In contrast to the debris-avalanche deposits, these deposits contain an abundant matrix of mud, sand and gravel, and any protruding boulders are coated with that mixture (Figure 2b). These flows may be described as *muddy debris flows*: macro-viscous flows in which the behavior of the flow is dominated by the viscosity and strength of the fluid (Johnson 1996). Muddy debris-flow deposits were found only in the westernmost three of the five main distributary channels.

Due to the interaction of the flow with the edges of the channel, the debris travels more slowly at the margins than in the center of the channel (Johnson 1965). This velocity distribution is reflected in the rounded plan shape of the wave front. As the wave travels, boulders in the wave front are pushed aside and may be deposited along the edges of the channel or in overbank deposits, forming *debris levees*. At Tumalt Creek, the muddy debris levees range up to 2 m in height and contain boulders up to 2 m in diameter, cobbles, and muddy material. (Figure 2b).

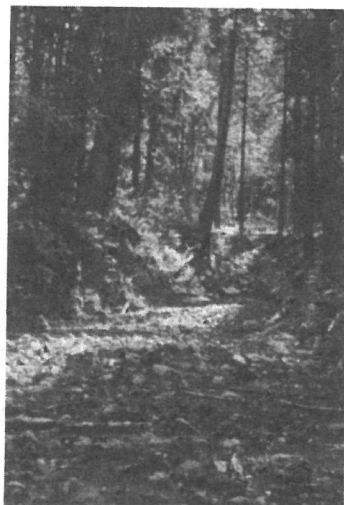
Figure 4b: Medial deposit of the muddy debris flow. The top surface of the cobbles and boulders on the surface are coated with muddy material. The flow descended a 35° slope (right center) without leaving a medial deposit.

Medial deposits are deposited along the axis of the channel through which the flow passes. The deposits consist of the fine material from within the body of the flow and are much finer than the adjacent levee deposits left by the same flow. The medial deposits of the muddy debris flow are about 10 cm thick and are comprised of muddy material, cobbles and occasional small boulders (Figure 4b).

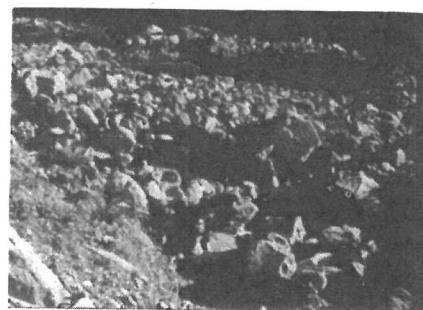
Figure 5b: Close-up of frozen debris wave in Figure 5a. Deposit contains only sparse fine material. Largest boulders in front up to two meters in diameter. Channel wall covered by plants in the lower left was left intact by the passage of an earlier debris avalanche.

Figures 5a and b show an example of a frozen debris wave deposited by a debris avalanche, and may typify the composition of a moving debris avalanche. In contrast to a frozen debris wave deposited by a muddy debris flow (Figure 4), this frozen wave contains only sparse fine-grained material, even in the rear of the deposit. Debris levees deposited by a debris avalanche contain less than 5% of fine material, and the voids between boulders have just a thin coating of muddy material (Figure 2a). In contrast, an adjacent muddy debris-flow levee contains approximately 30% fine material (Figure 2b). The lack of a matrix in these debris avalanche deposits indicates that the fluid phase drained from the deposit after deposition, or that it consisted primarily of water. In any case, it was a fluid of low strength and viscosity.

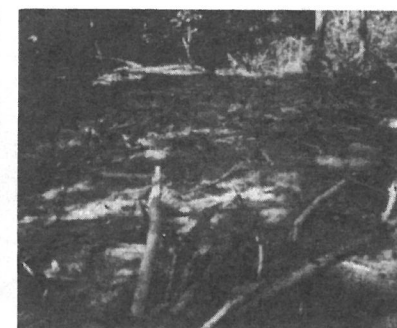
Figure 7a: Frozen debris wave 1/2m thick. Front of the wave in the background composed of small boulders and cobbles.

The distal parts of the fan show an increase in the percentage of fine material in the frozen debris waves deposited by debris avalanches. A possible explanation is that, as the debris waves traveled, they systematically rid themselves of their coarsest material in producing debris levees, thereby increasing the proportion of the finer-grained material in the remaining flow. A finer-grained frozen debris wave deposited by a debris avalanche is seen midway down the fan in Figure 6c. Frozen debris waves are plentiful and even finer-grained on the distal parts of the fan (Figures 7a and b).

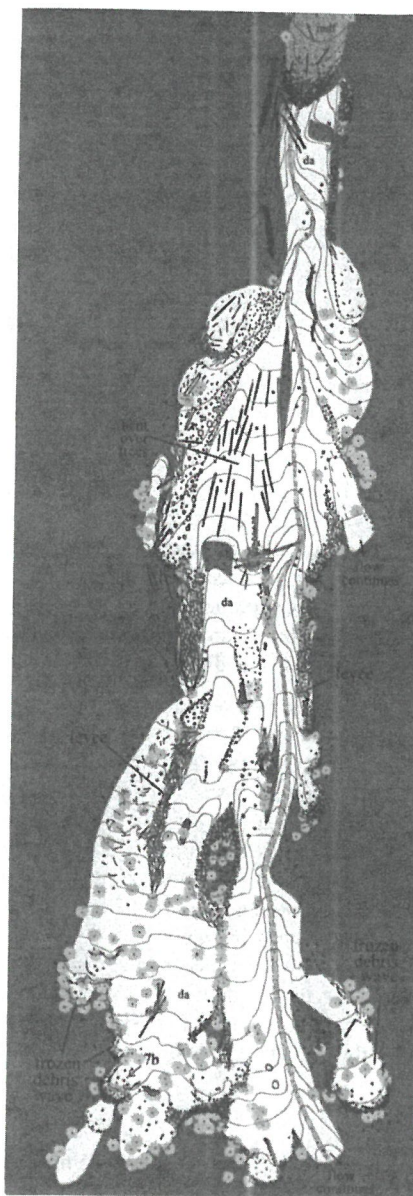
Figure 7b: Map of distal deposits of the debris avalanche. The debris is deposited in numerous frozen debris waves, each up to one m in thickness.
