RESTORATION TO WOOLDRIDGE MONUMENTS Mayfield, Kentucky April-July 2010 Page 1
Monument Conservation Collaborative LLC, Norfolk, CT 06058

Restoration work was done in 3 phases, starting in April 27, 2010. This first phase included the attachment of loose fragments, erection of the granite obelisk, the Keziah Wooldridge torso and the stabilization of the horse monument. Also accomplished was the re-attachment of all the fragmented feet and legs in preparation of setting the torsos in the following trip.

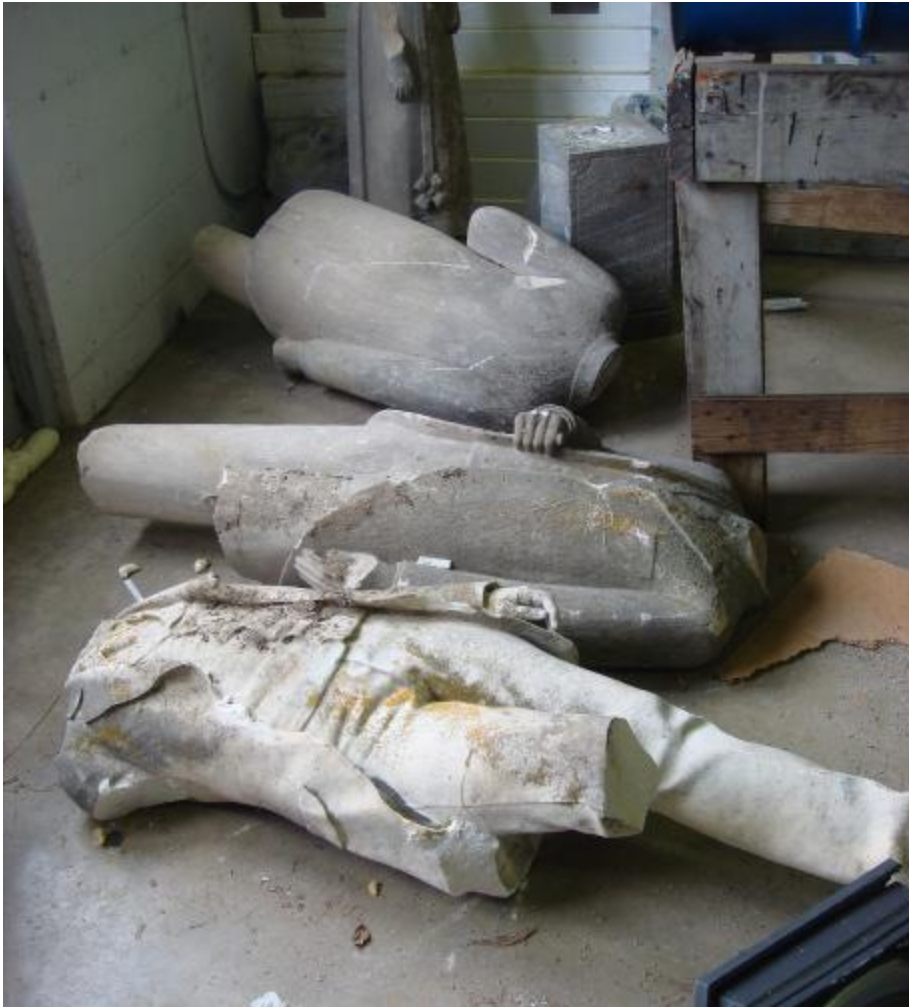
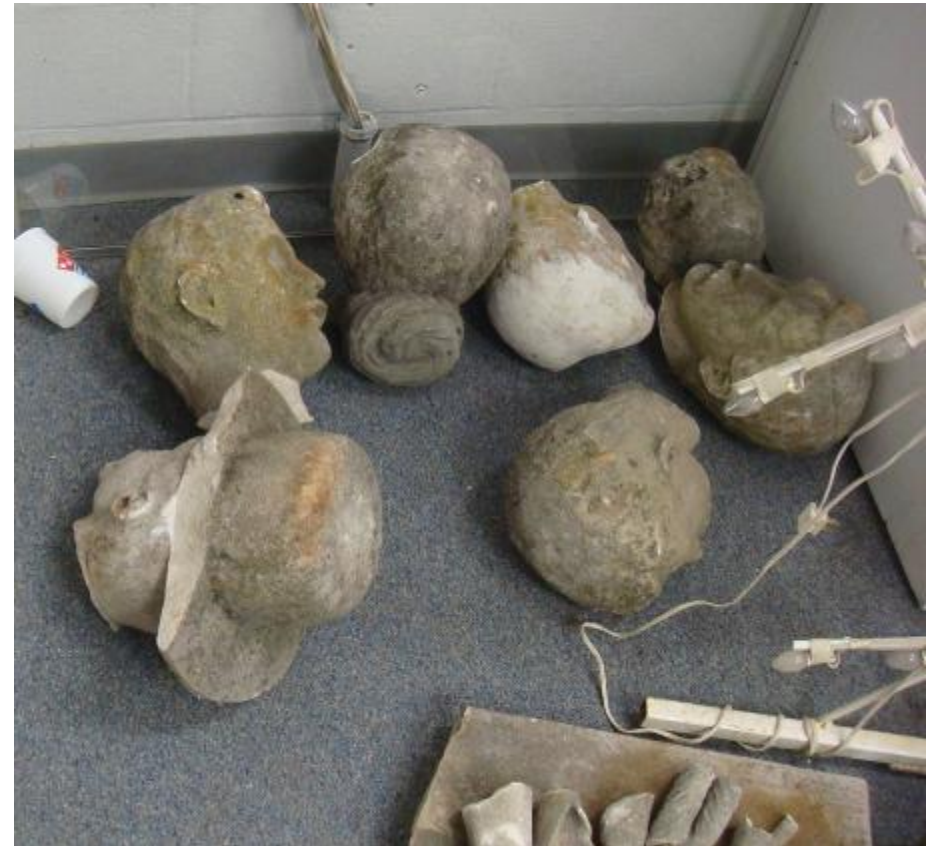
4/27/2010 General existing conditions

Fragments collected by the Mayfield Public Works Department and stored at their facility.

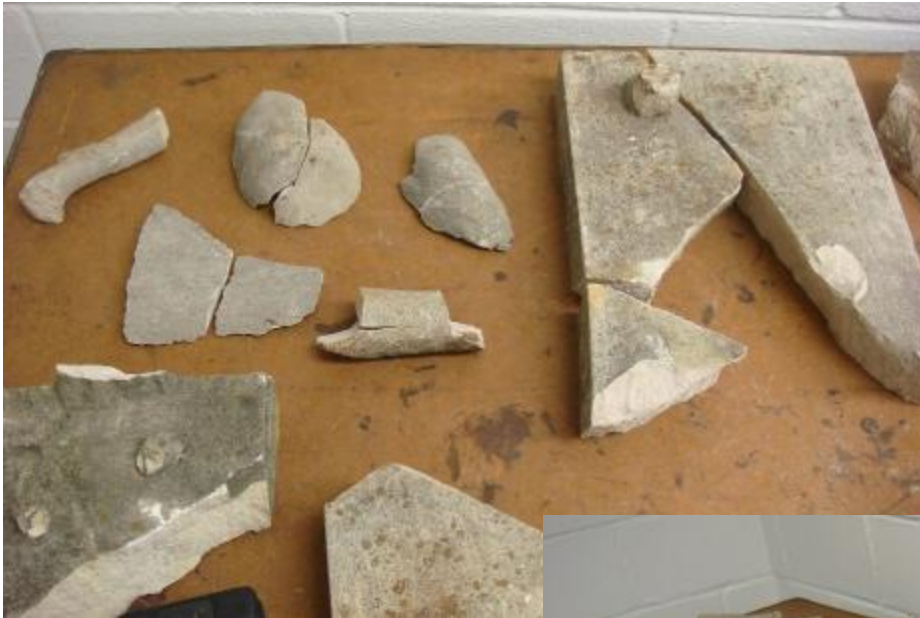
Initial inspection and sorting of fragments at Public Works facility.

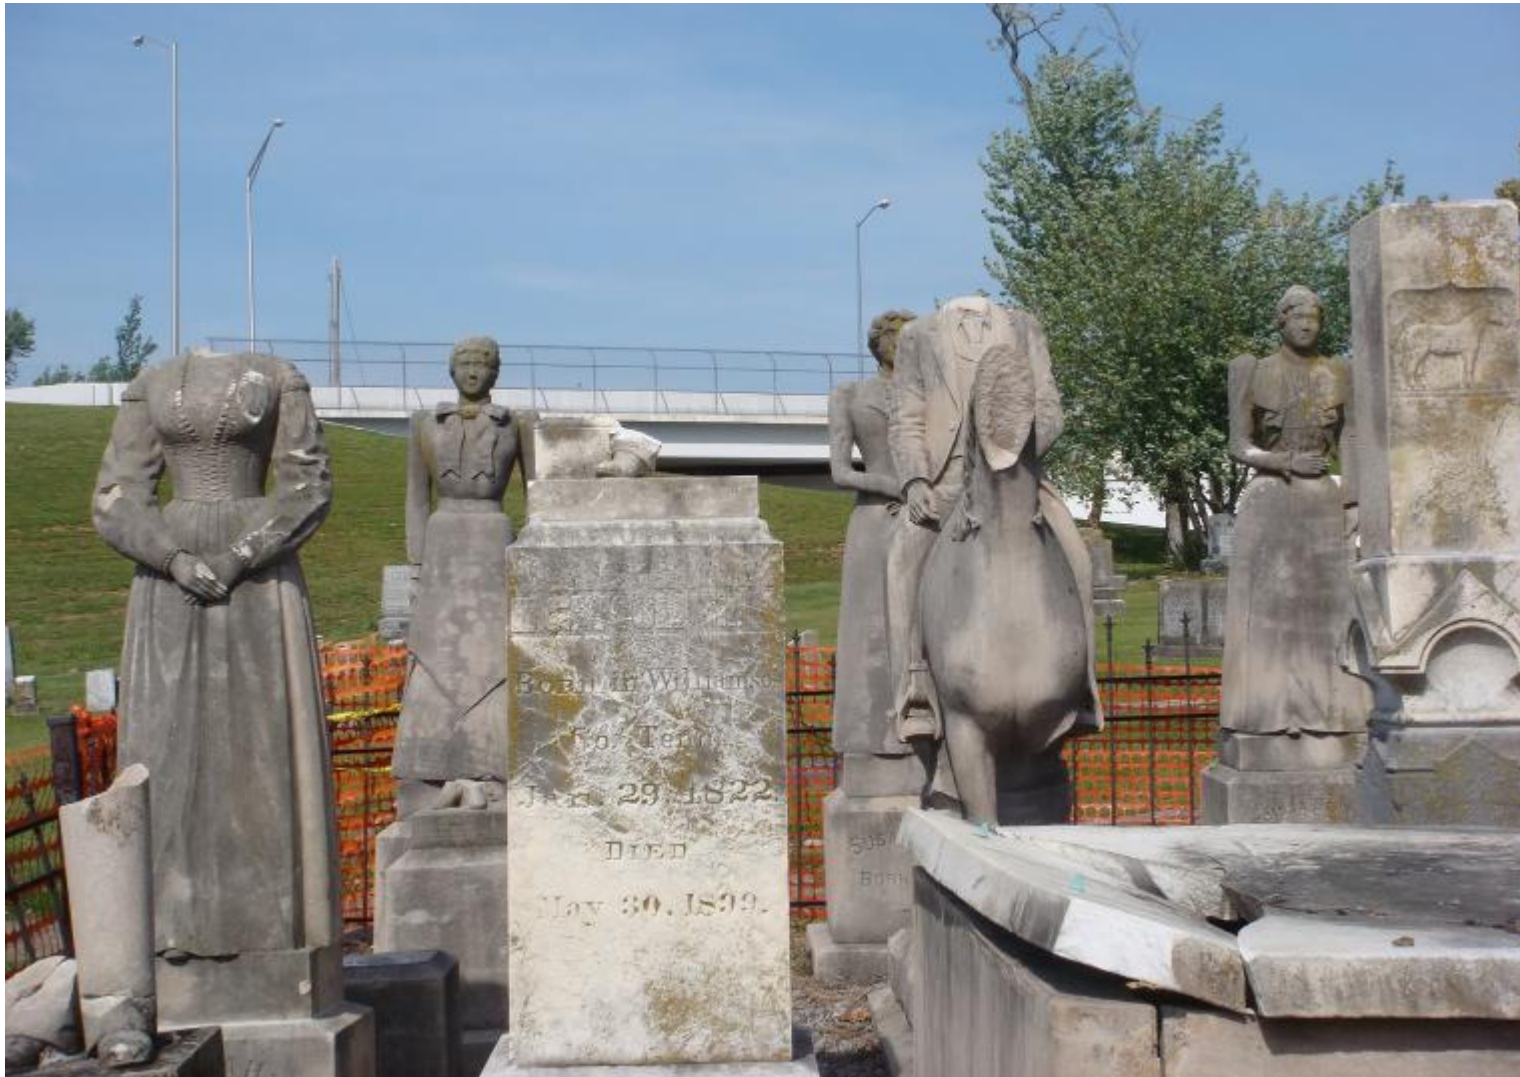
The headless horse and rider and Keziah reset. On the right is the carved marble element of the granite and marble obelisk which was reset with the help of the crane.

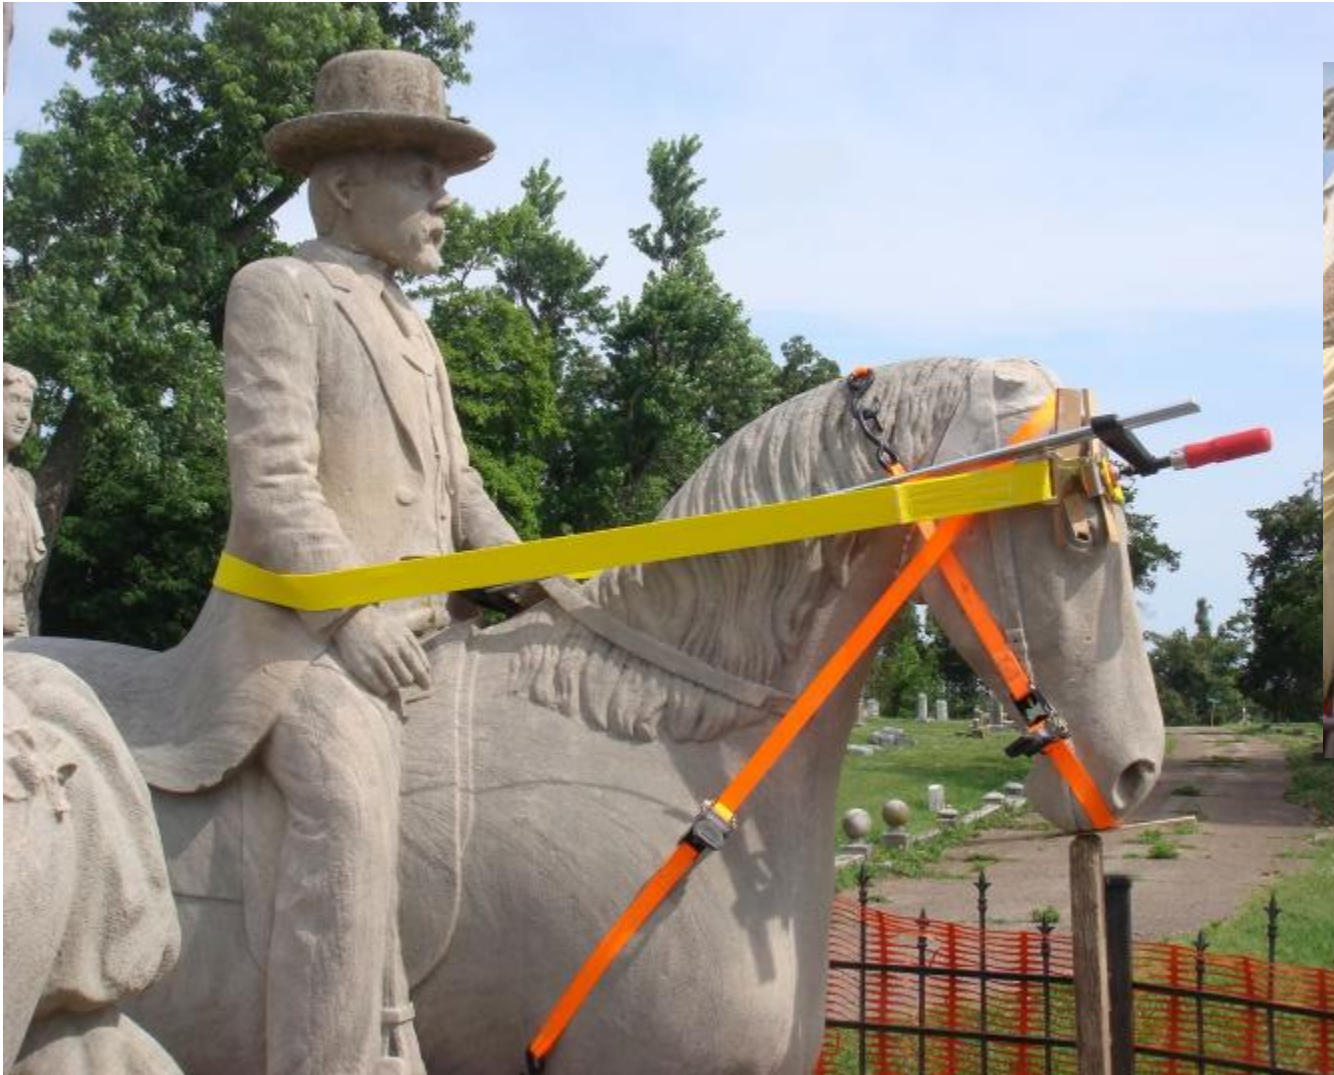
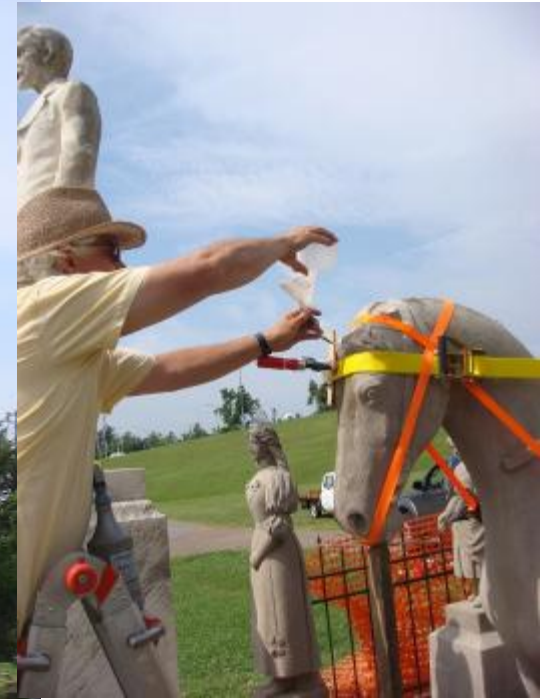
Because of the vertical break, the re-attachment of the head was more complicated than the horizontal fractures. After curing of the adhesive of the stainless pins, the head was drilled to fit the pins and was attached with adhesive and held in place with clamps.

A hole had been drilled though the forehead of the horse into the cavities where the pins were set. A cementitious grout made fluid with a super plasticizer was then poured into the cavities to provide a secure attachment of the pins to the horses' head

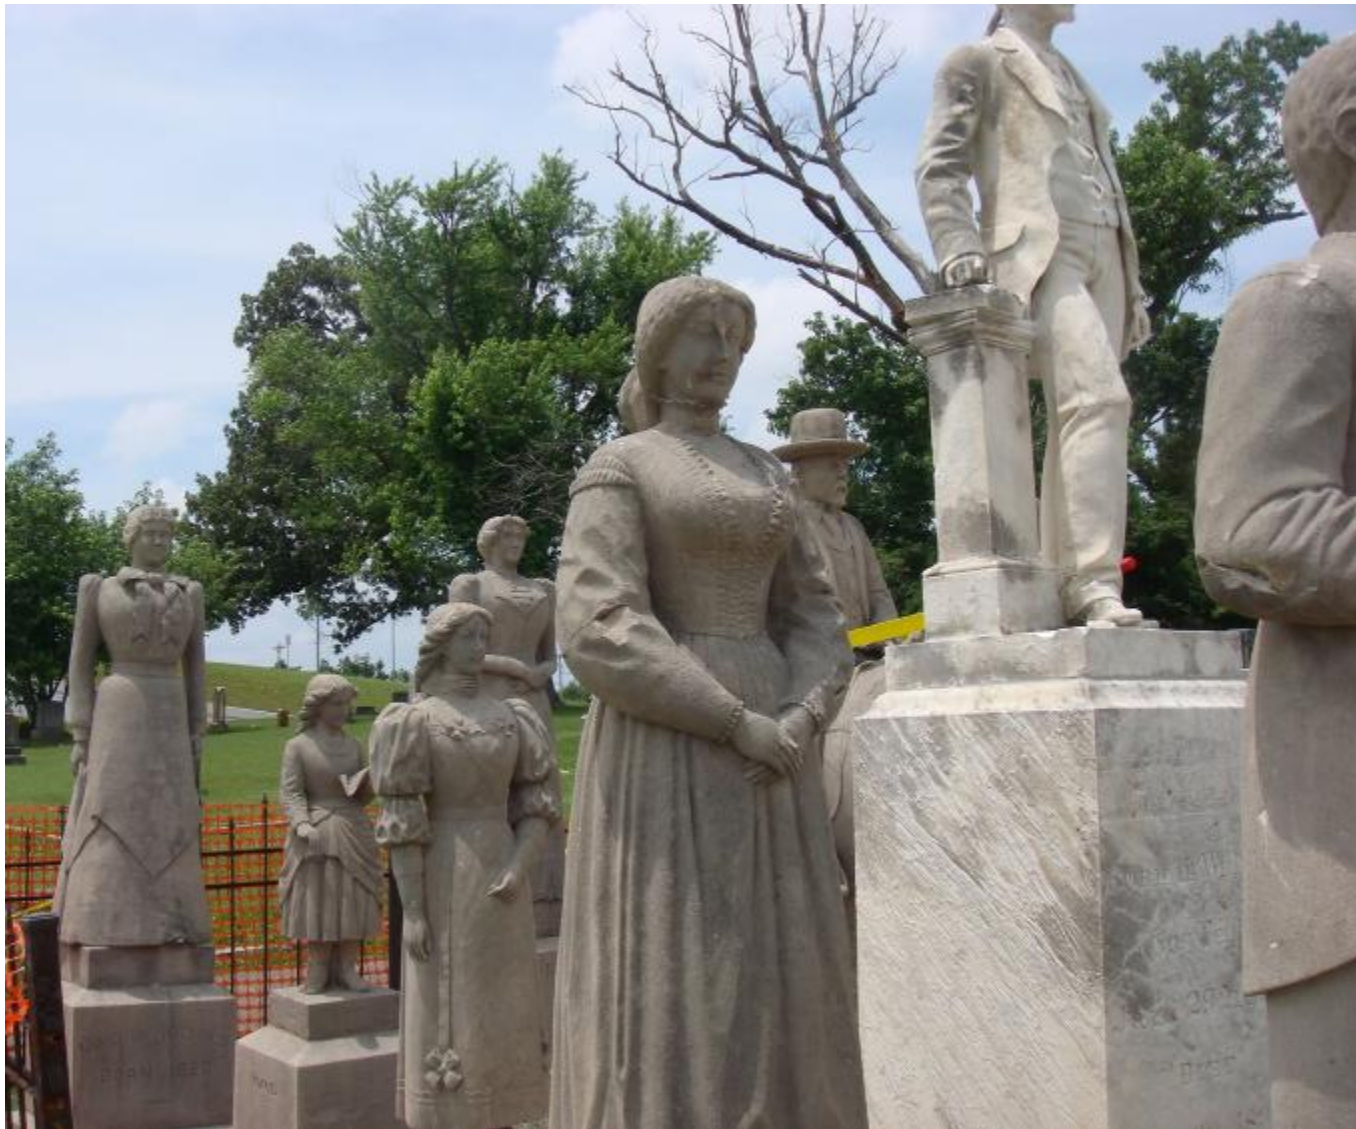
General condition of monuments at the end
of our June visit

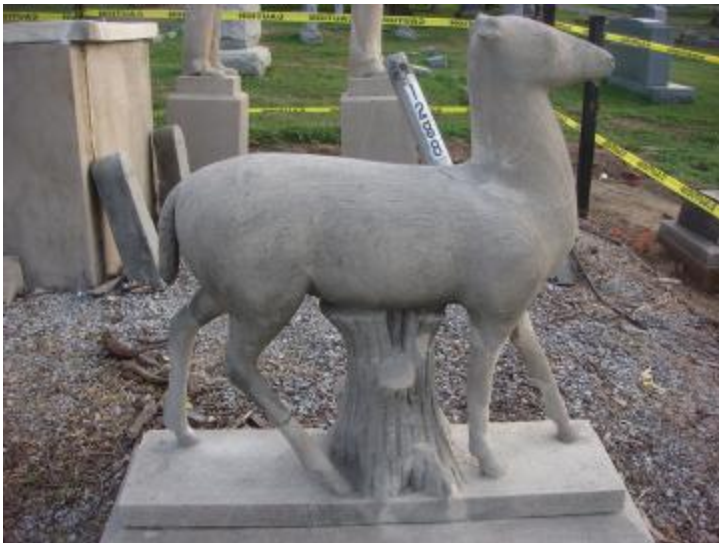
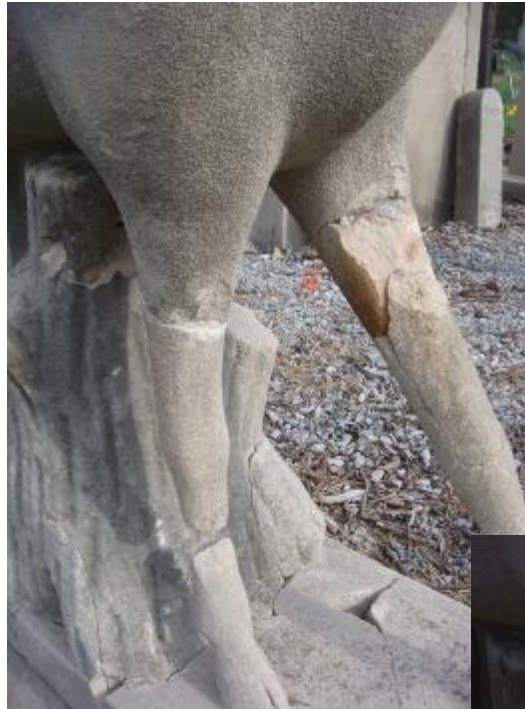
On the left, before patching; below after.

July, 2010. All small cracks filled with 000 pigmented crack filler and larger losses filled with pigmented Jahn restoration mortar

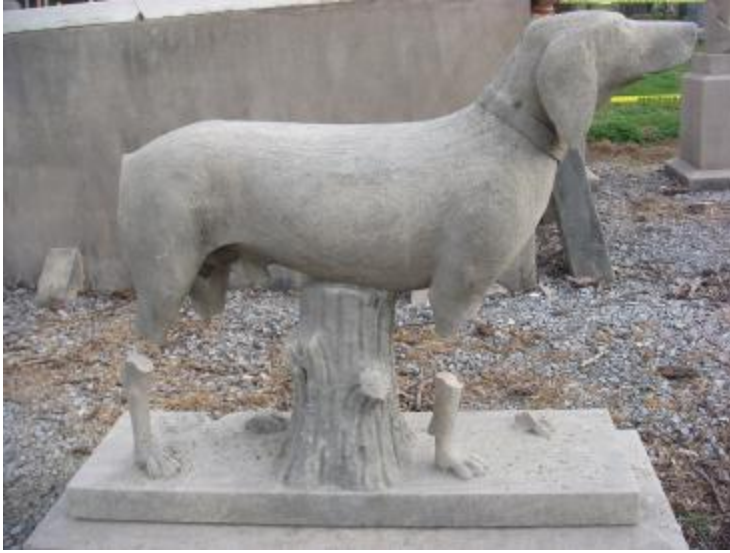
The dog figure was missing parts of his feet. Threaded stainless rods were first epoxied in place to be used as armatures for Jahn mortar.
