# MAVRIC SL - Disclaimers

# MAVRIC SL in the Knee

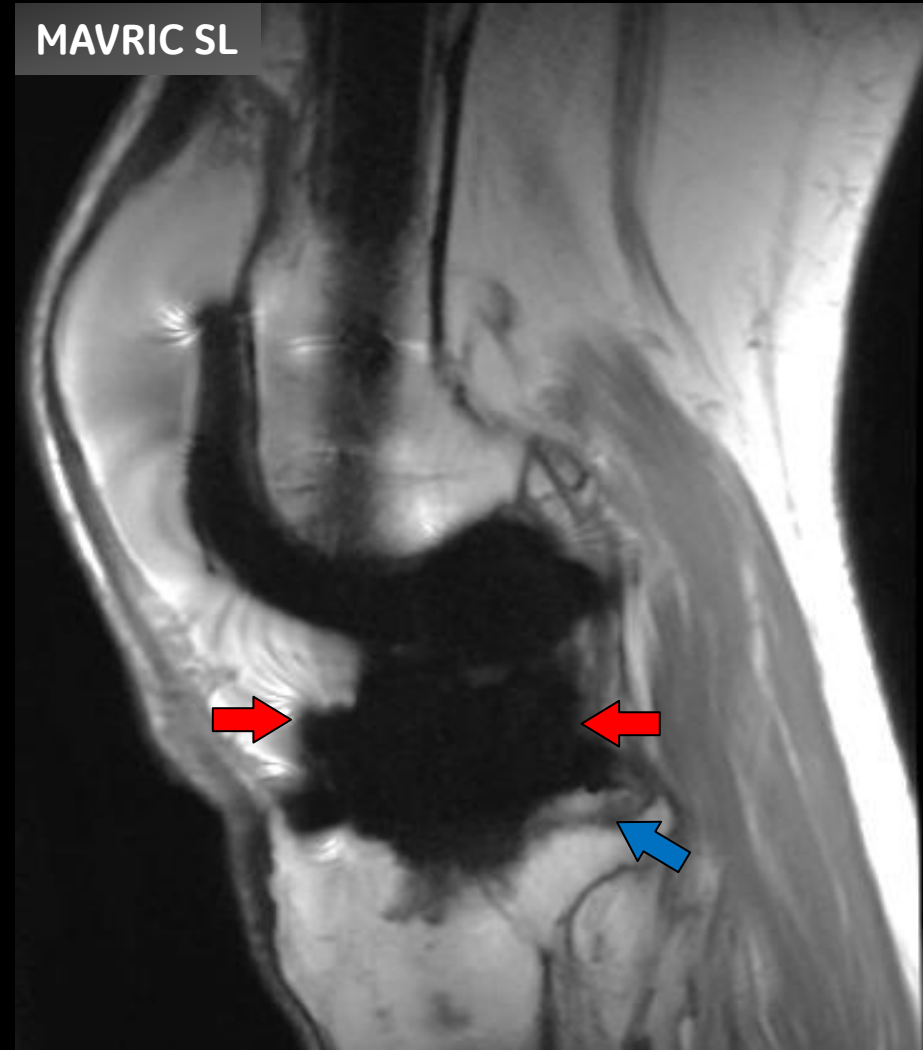
2D PD FSE (MARS)

Note visualization of bone interface around the femur (red arrow), and posterior tibial osteolysis (blue arrow) on the MAVRIC SL image (right). MAVRIC demonstrates clear outline of polyethylene (red arrows) and posterior tibial osteolysis (blue arrow)

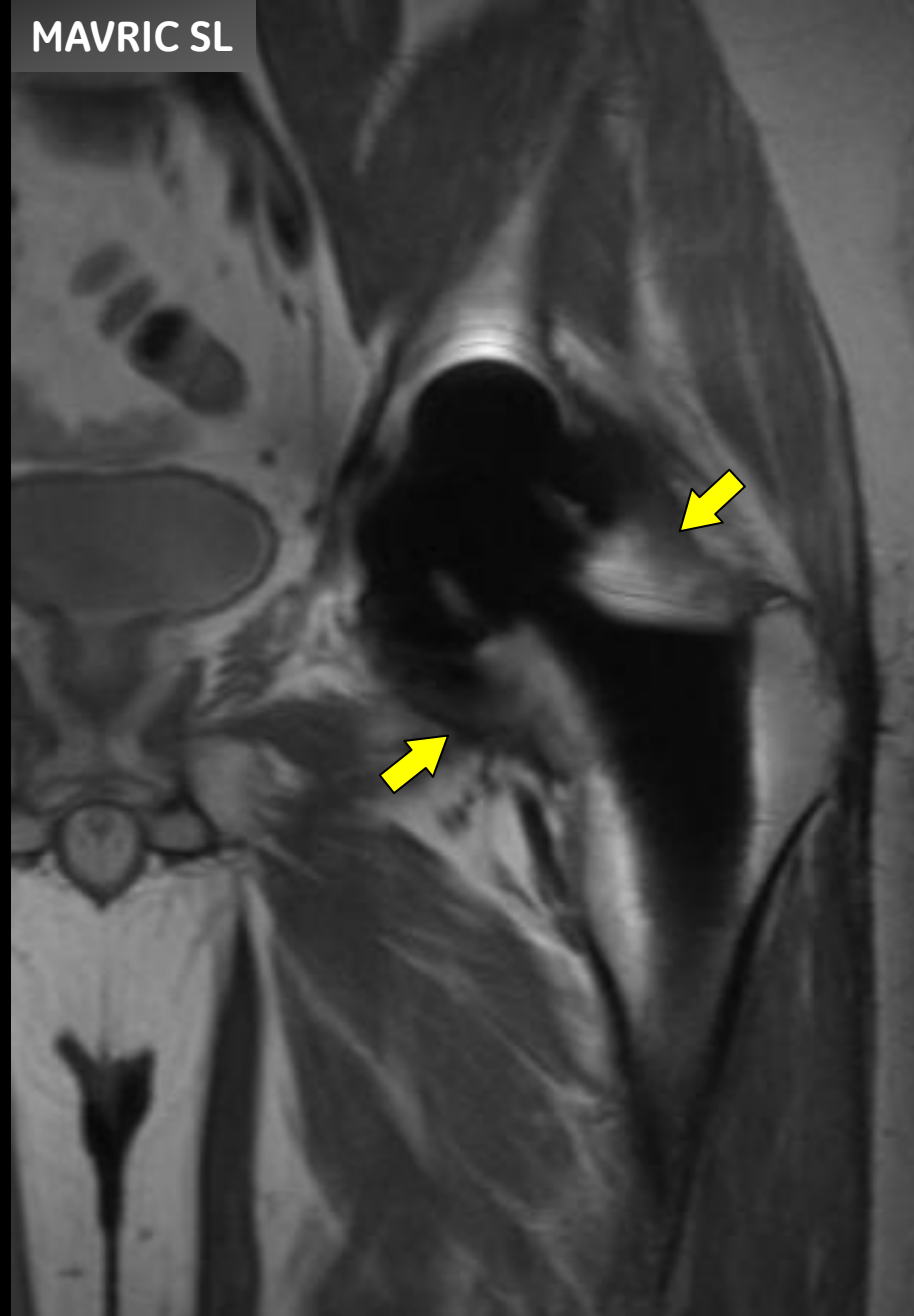
2D PD FSE (MARS)

## Metal-on-Metal Hip Implant:

MAVRIC SL demonstrates ALTR with markedly thickened synovial lining (arrow)

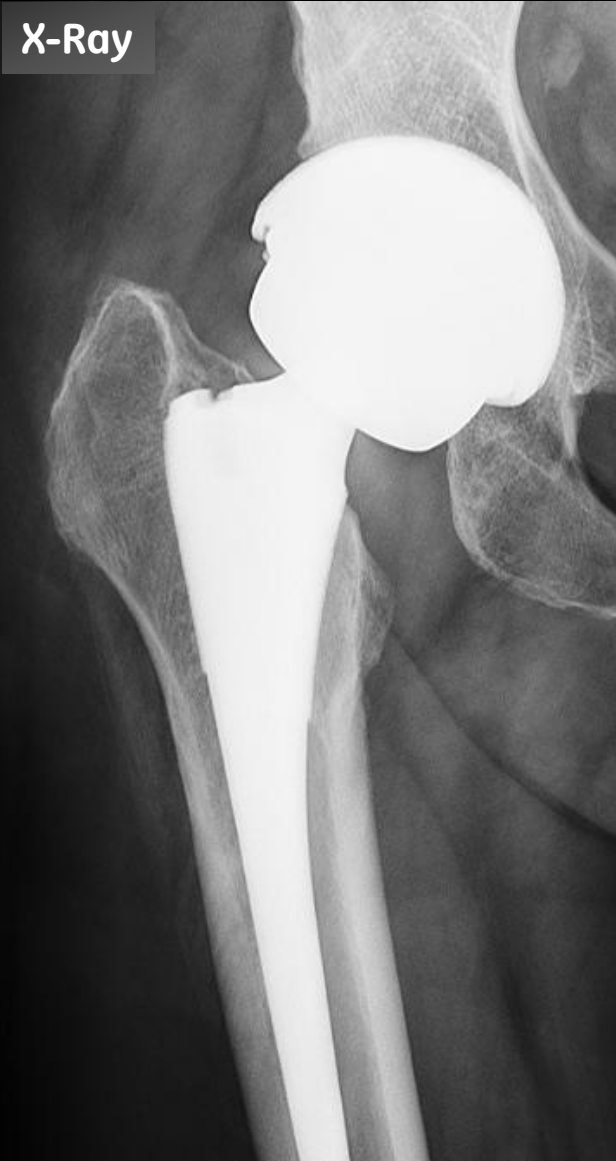
MAVRIC SL demonstrates evidence of an abnormal synovial response indicative of an adverse tissue reaction (arrow)

- 65 yo with severe pain over several month duration, following total hip replacement 3 years earlier
- no pathology seen in X-Ray or conventional MRI
- MAVRIC SL showed clear evidence of an abnormal synovial response indicative of an adverse tissue reaction (arrow)
- the patient was indicated for a revision surgery

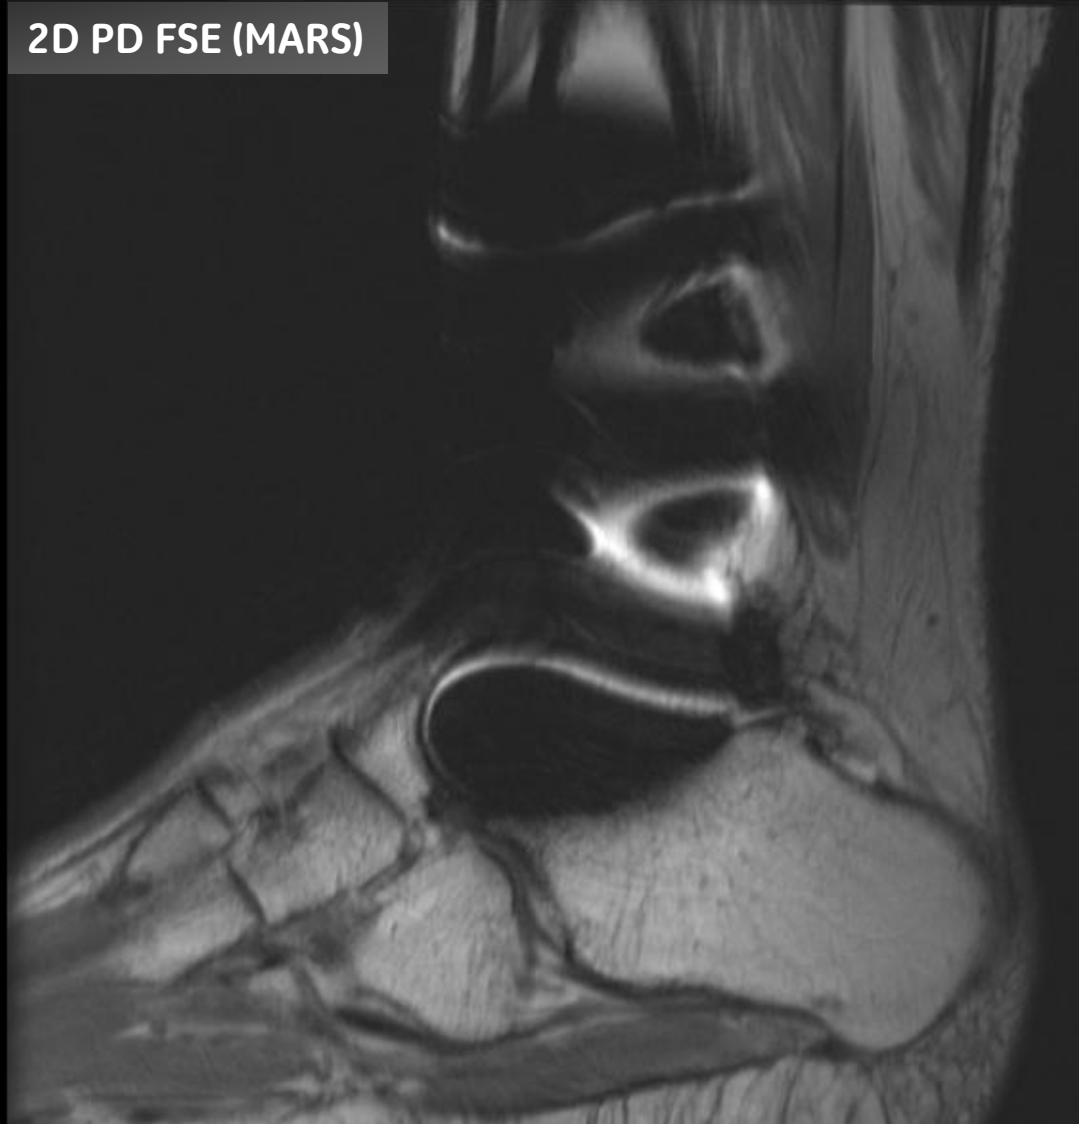
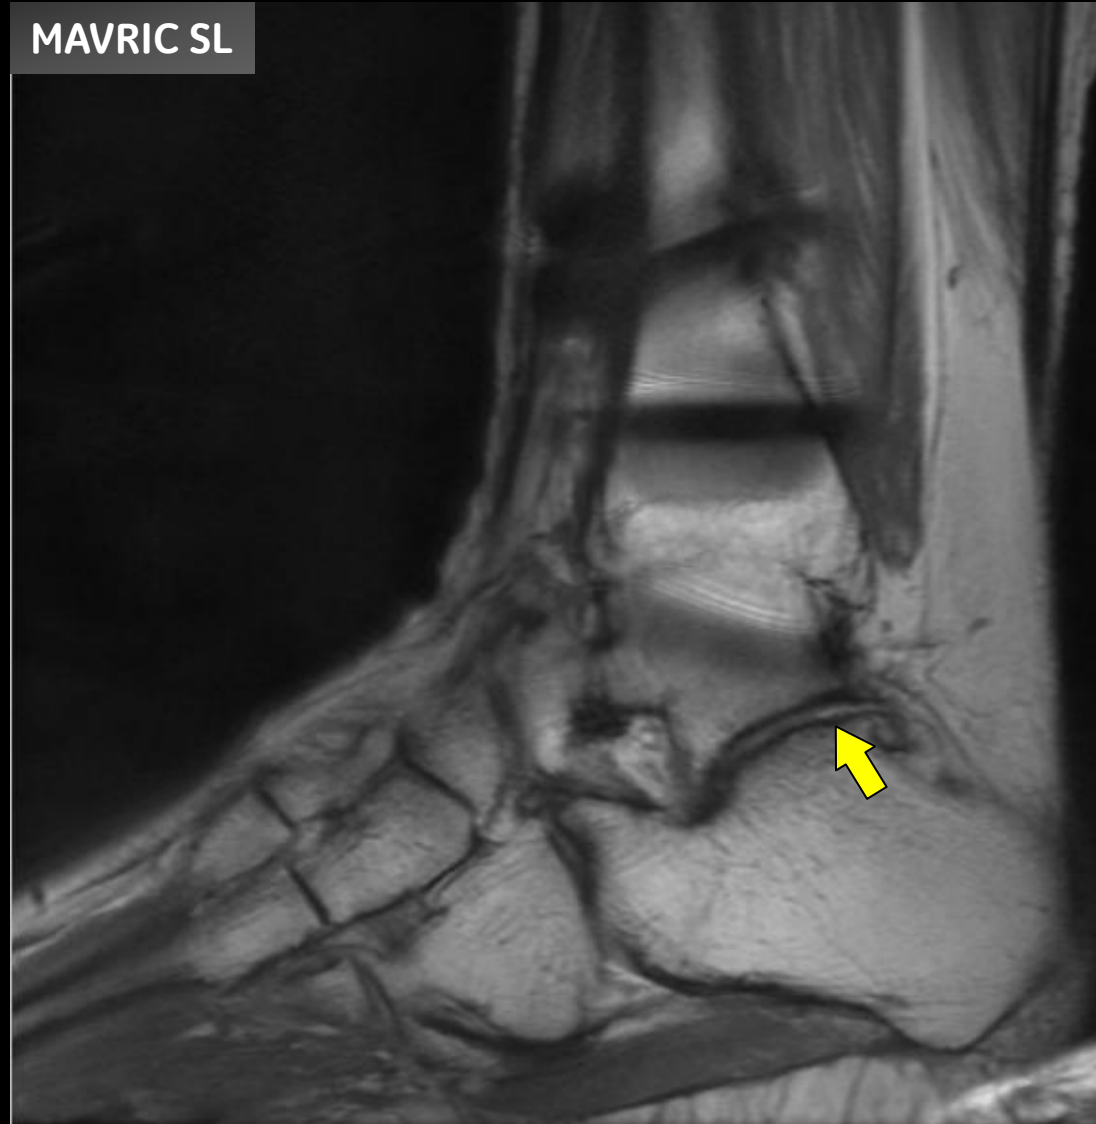
2D PD FSE (MARS)

Visualization of posterior facet cartilage in the presence of tibial fixation hardware (yellow arrow)
