Facility Name: Lafayette Academy-V. Keeler (Demo-Reno Contractor)  
City: New Orleans Parish: Orleans  
Date: 3/22/2017 Reason: Inspection

AI: 99938, 8555  
Photographer: L. Maloan  
Other ID #:

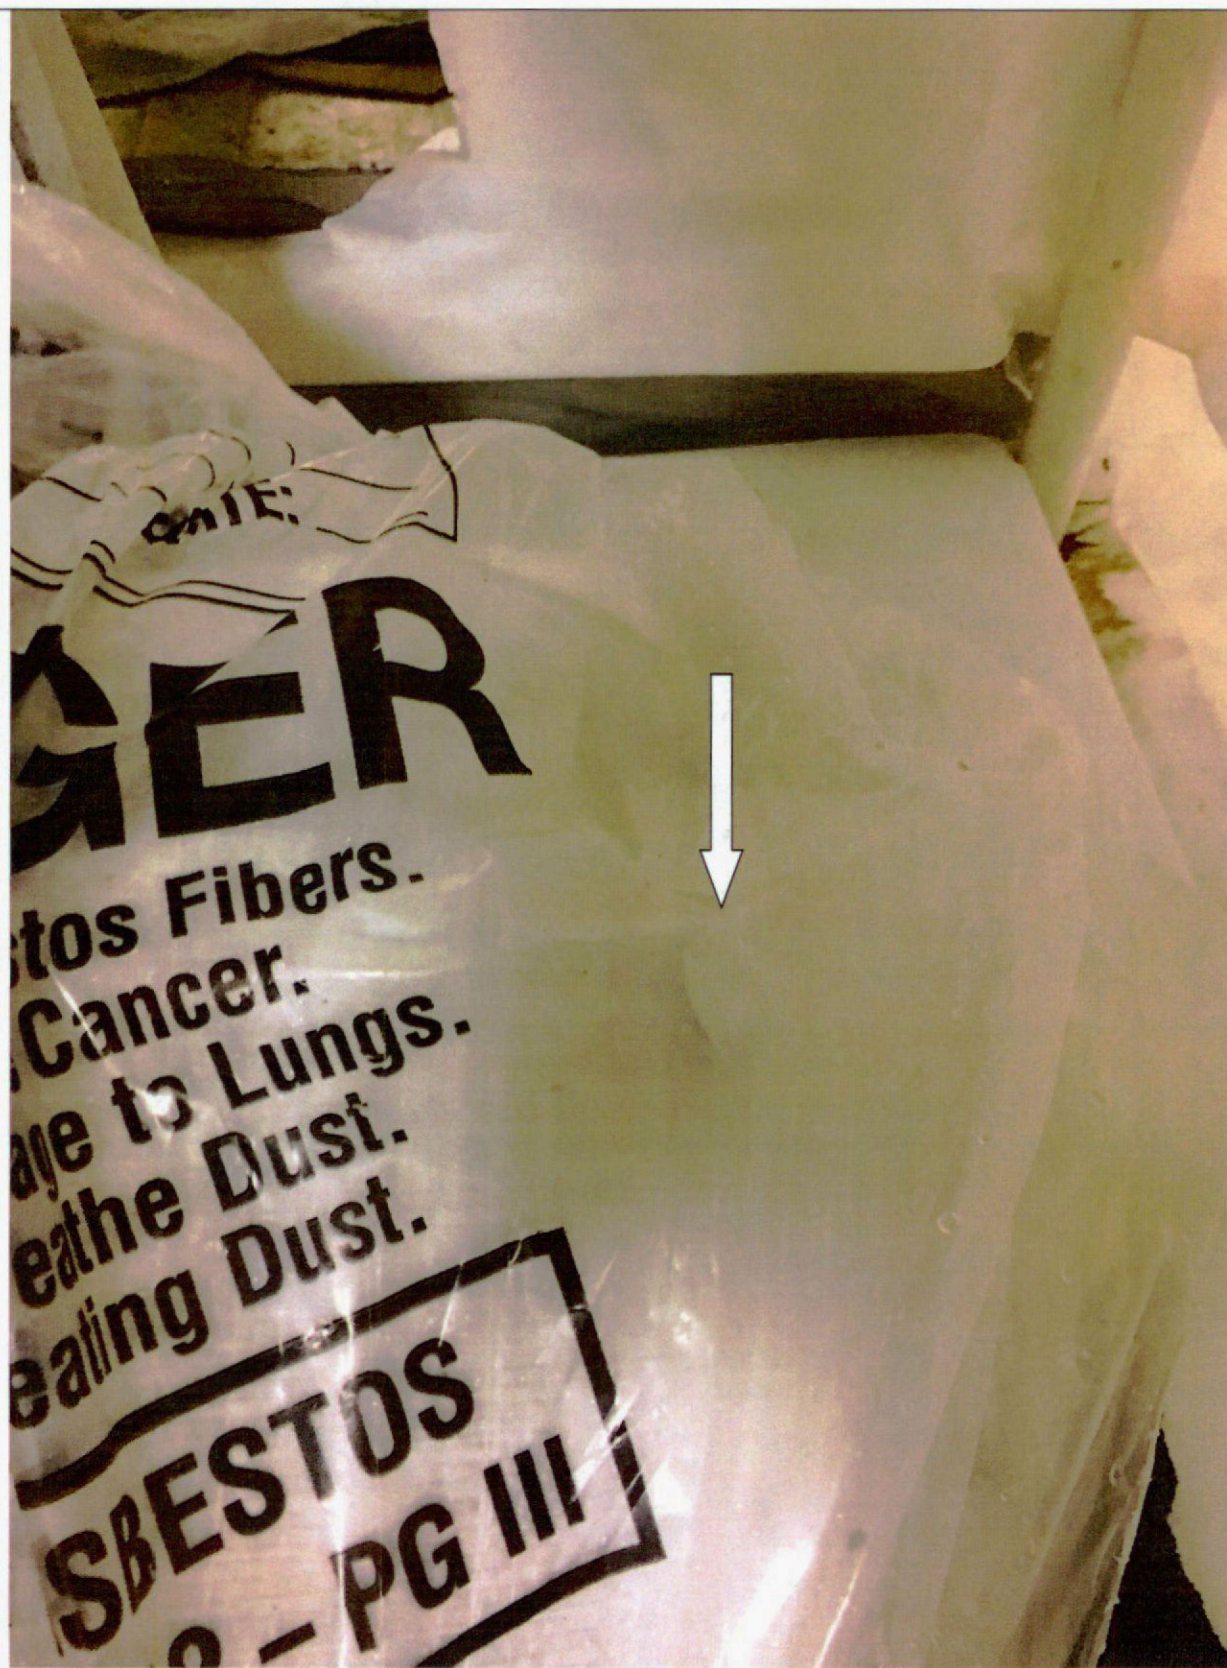
Photo #: 4 of 5

Description: A bag pulled from inside containment. According to the on-site supervisor, the generator labels inside the bags were crumpled and unreadable at the time of inspection due to the water inside the bags.

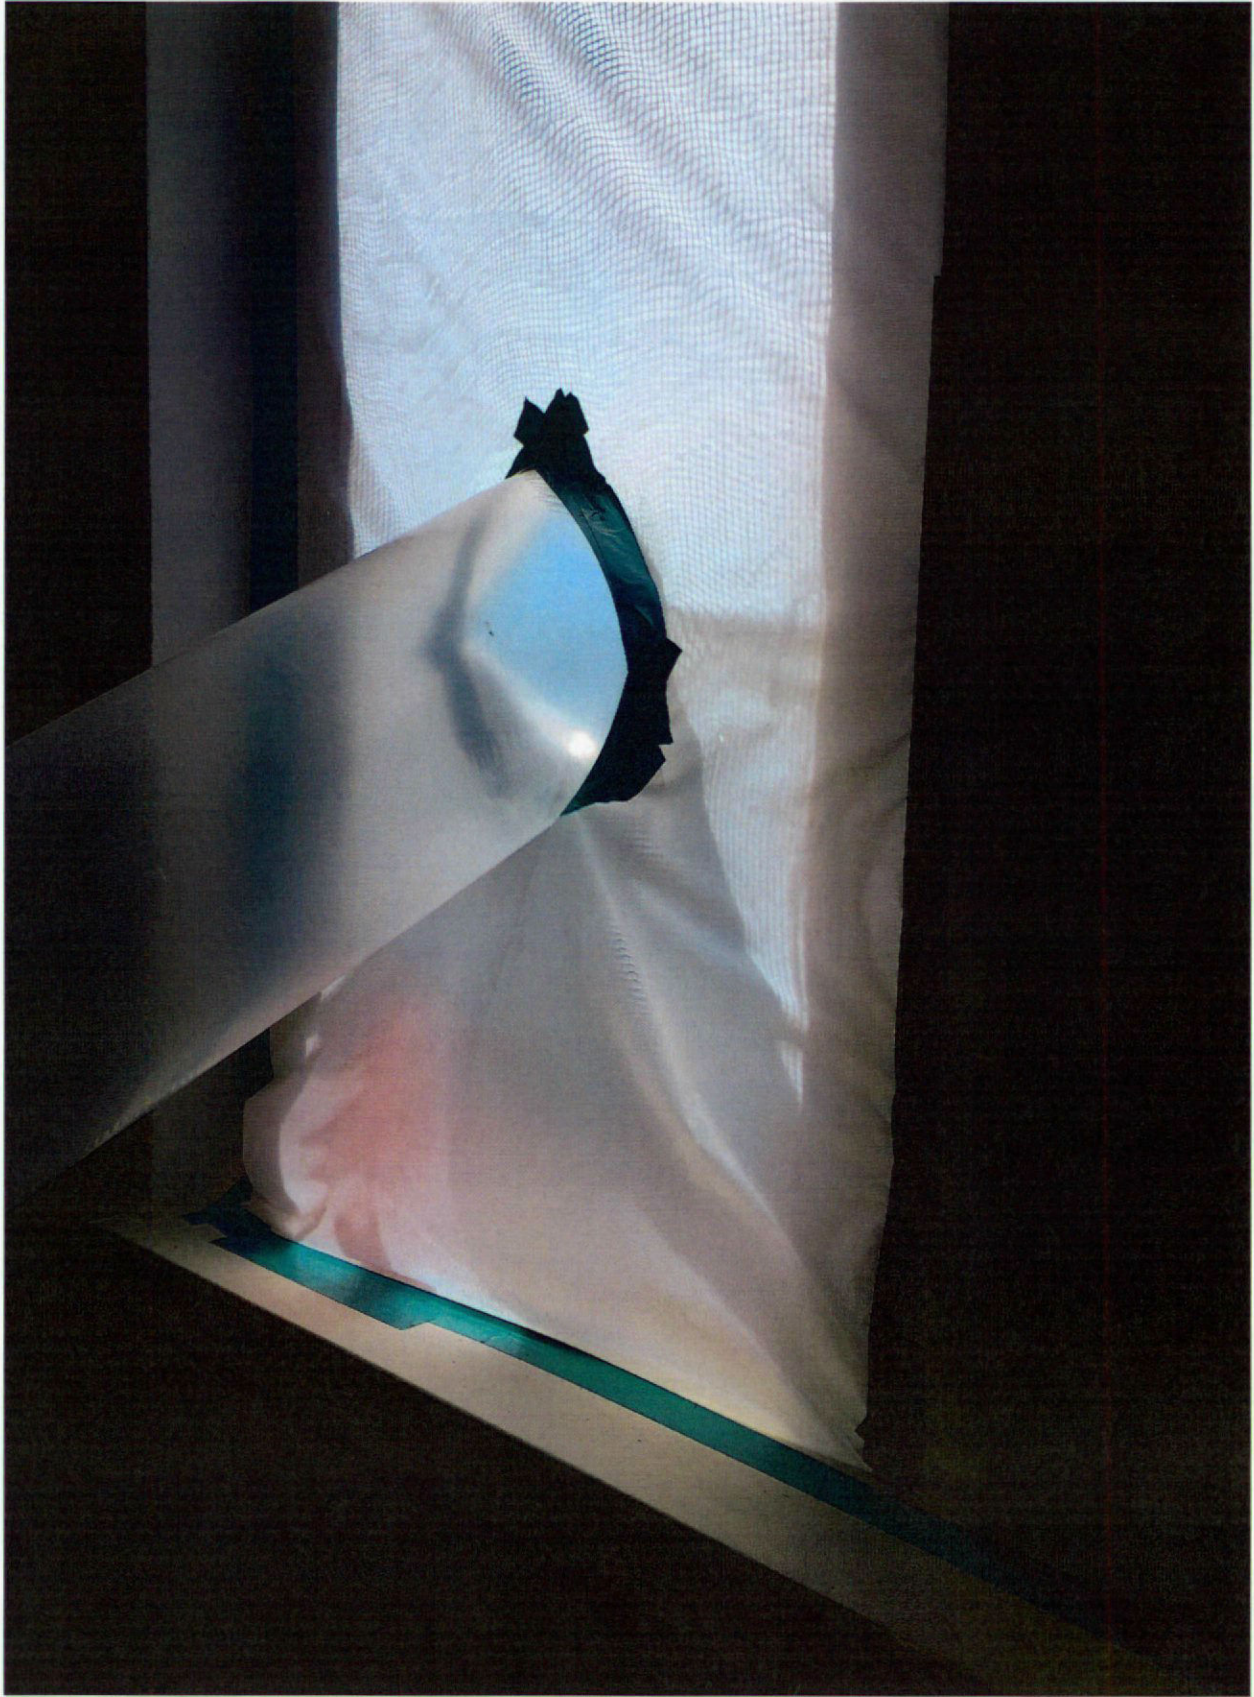
Photo #: 5 of 5

Description: Negative pressure units were not fully functional.
