**SUBJECT:** Transmittal of Final Report - High Lead at Three Residences in Flint, Michigan

## High Lead Levels in Flint, Michigan

The purpose of this report is to present the findings of activities conducted in response to high lead levels in drinking water reported to the United States Environmental Protection Agency Region 5 Office (EPA) by a resident in the City of Flint, Michigan.

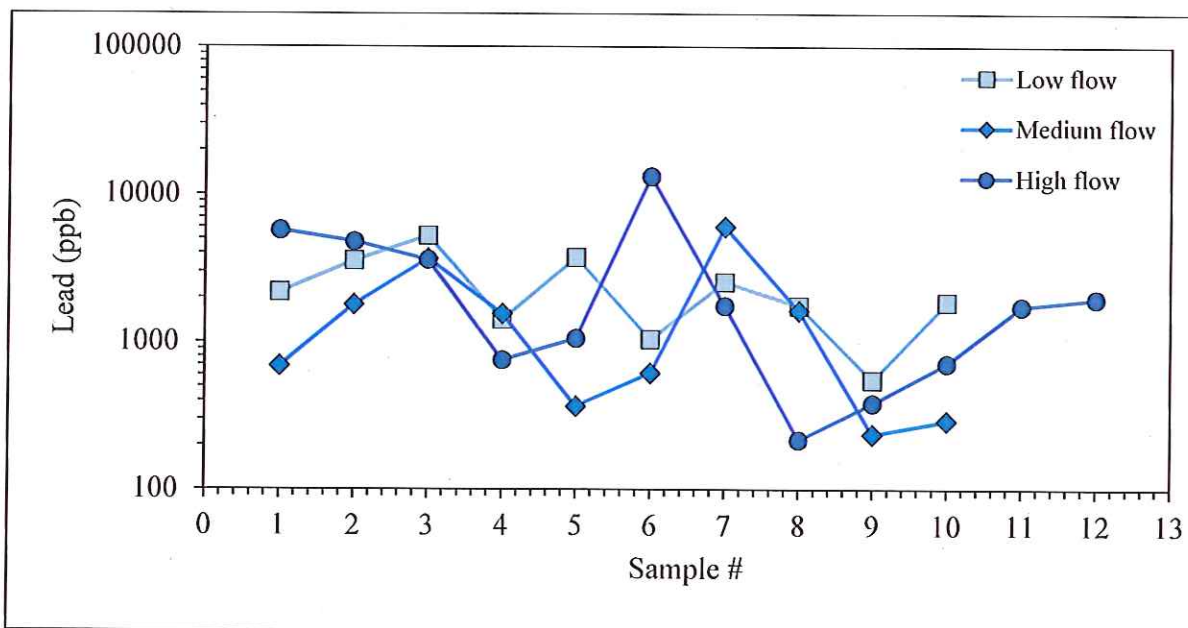
#### Virginia Tech Sampling Results (provided courtesy of Virginia Tech)

Samples were collected from the [redacted] home following an extended stagnation period (April 3, 2015 to April 27, 2014) after the water at the [redacted] residence had been shut off. The water was turned back on and three sets of sequential samples were collected on April 28, 2015, at different flow rates (low, medium and high).

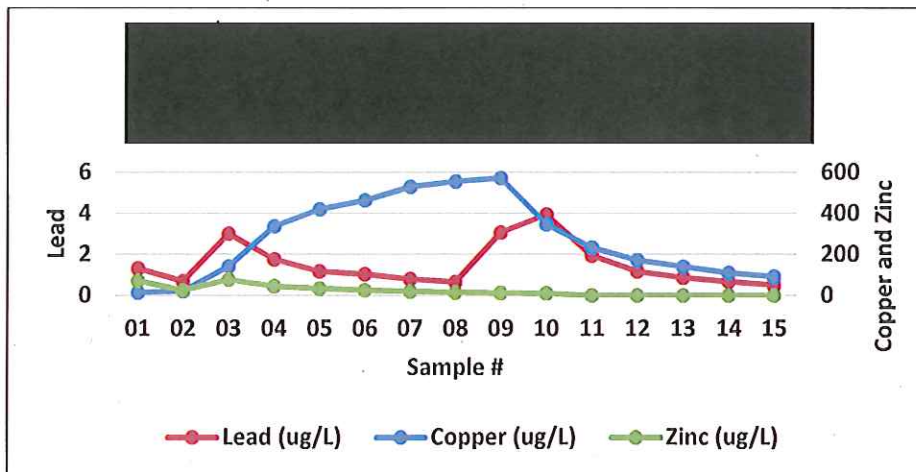
█ (█ home)

Following the replacement of the █ original service line, a series of 15 sequential samples were collected from the kitchen tap to measure the lead levels and other parameters to ensure that the high lead from the original service line had not contaminated the interior plumbing at the █ home. With the exception of two areas, lead levels were low throughout the █ plumbing following the service line replacement. The two sources of lead that were still detected in the plumbing are likely the water meter (Sample 3) and the new external service shut-off valve (Samples 9-11). Although new brass plumbing components must be lead-free, there can still be some lead that is released from these components.
