June 19, 2014 Draft

Water Technology Project # 13399.01

Project Description: The Traverse City Water Feature was conceived as an interactive, educational water playground for citizens and visitors to downtown Traverse City, MI. Designed and constructed during 2012/2013, the Water Feature is located in Clinch Park, a waterfront park in downtown Traverse City. Part of Clinch Park's bay front plan, the Water Feature work was part of a more general scope which included landscape areas, a concessions & bathhouse building, an accessible kayak launch, a playground, walkways, decks and civil improvements. The intent of the Water Feature is to provide an inter-active, educational water feature for the public to play in. (Photo 01) The design of the Water Feature is intended to emulate the natural water cycle. (Photo 02)

Draft 6/19/14
Clinch Park

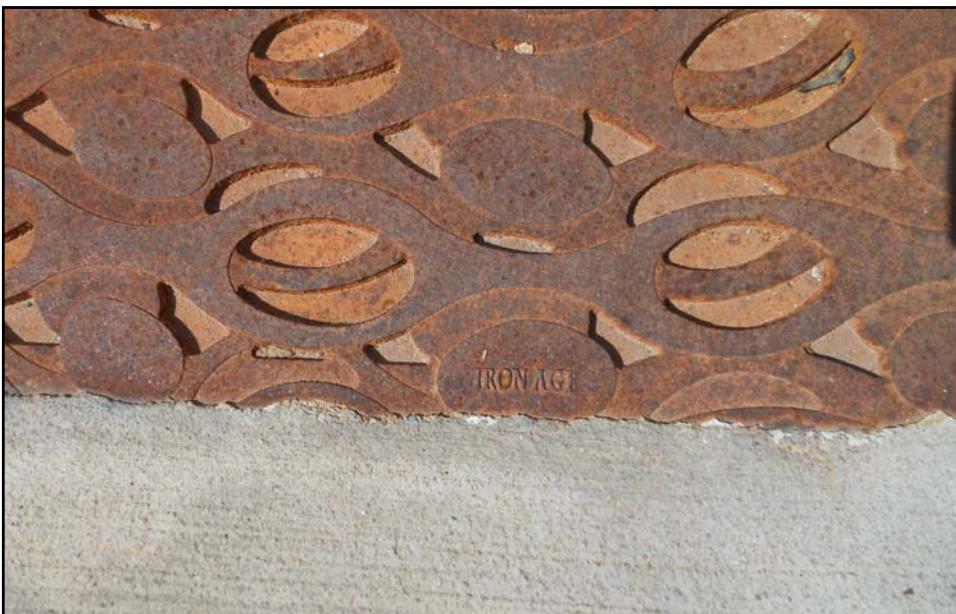
Photo 15

The perimeter stream trough is made up of iron gates with a decorative pattern(Photo 14). Specified in the project manual as "Water Weir Trough" by West Gate Sheet Metal, the installed product has an IRON AGE stamp, it is presumed that the grates were manufactured by IRON AGE DESIGNS of Burien, WA(Photo 15). This was confirmed with a search of the IRON AGE WEBSITE, which contained a drawing labeled "Clinch Park".

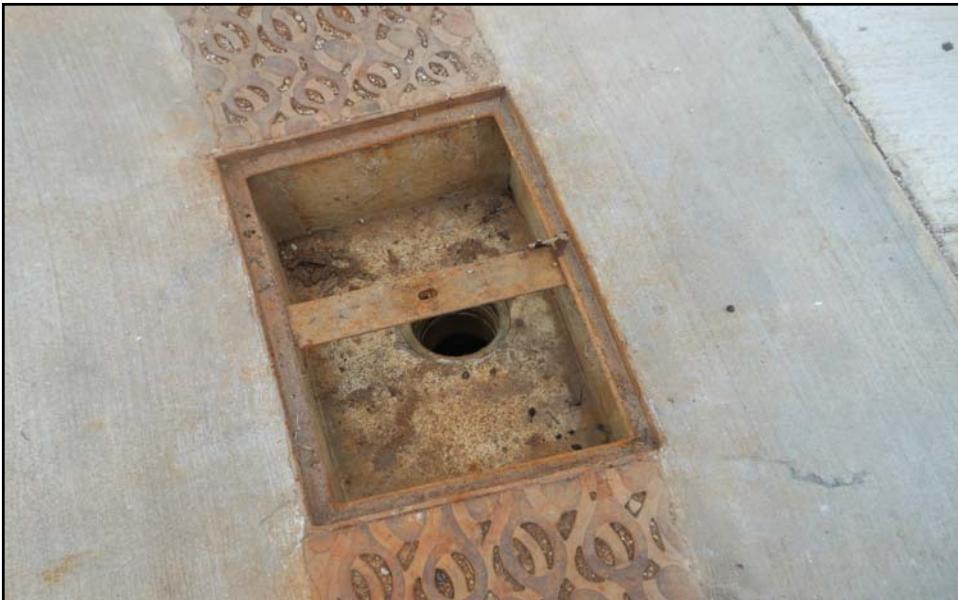
Photo 24

Preventing debris from entering the system initially is the best practice. Staff has attempted to do this with customized debris strainers inserted into the gutter dropouts (Photos 24 & 25). This attempt has had minimal success reported, as staff still needs to clean strainer baskets and backwash every ½ hour. As discussed previously, proper spatial design between debris sources (plantings) and the feature is required. The creation of seating areas and walkways would benefit this effort. Another option would be the installation of a pre-screen settlement tank, which would allow for initial screening of debris and sand settlement.

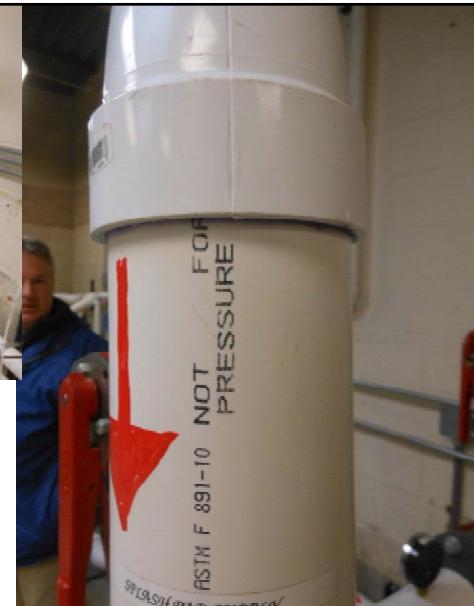
Photo 27

- 13. The filtration seems undersized, requiring backwash of system every ½ hour on busy days.** Staff reported that during hot days the feature must be backwashed frequently. Backwash water is sent to a 150 gallon holding tank which acts as a retention basin, releasing water at a metered rate through a 1.5" pipe (Photo 27). Backwashing frequencies of every ½ hour were reported.

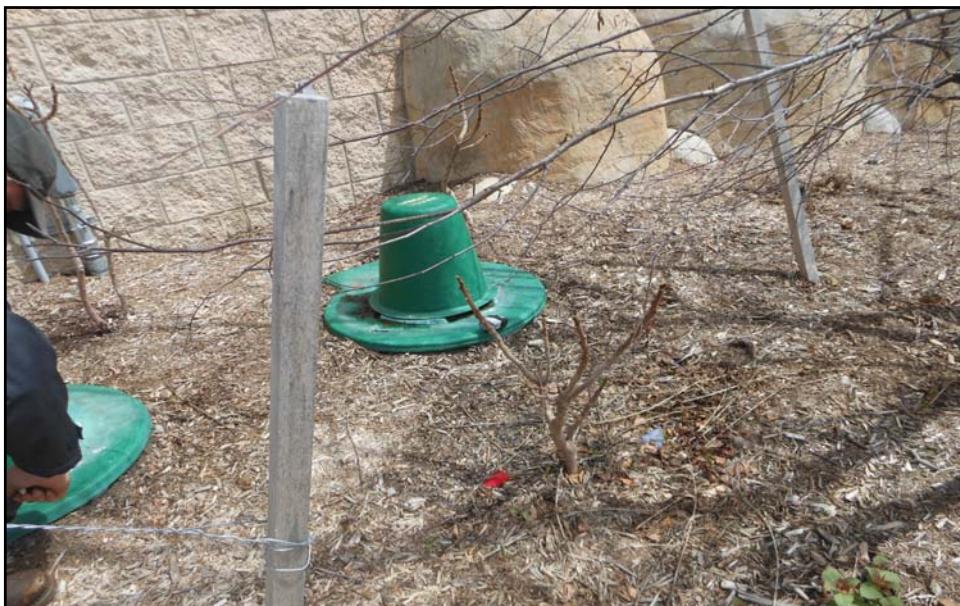
Photo 31

Comments: Staff expressed concern with access to the chemical tanks, both from a service standpoint and that they are exposed to park patrons. Located in a landscape area, the surrounding plantings render access to the units difficult (Photos 31 & 32). The units are accessed 3 times weekly to check chemical
