**MITCHELL PARK HORTICULTURAL CONSERVATORY
DOMES
Peer Review**

Milwaukee, Wisconsin

Final Report

WJE No. 2016.2700

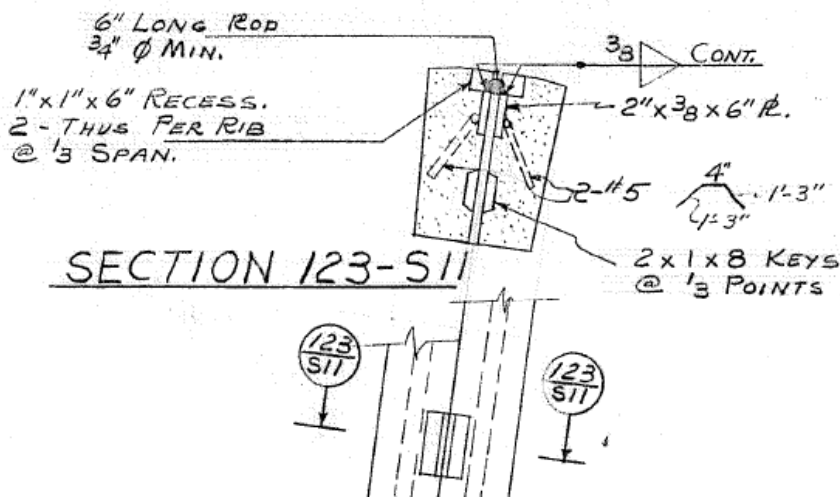
Figure 6. Typical precast concrete connection between members - reproduced from original drawings

9. Adjacent precast concrete members are attached together by welding a 6 inch long, 3/4 inch diameter rod between embedded plates in each member (Figure 6).

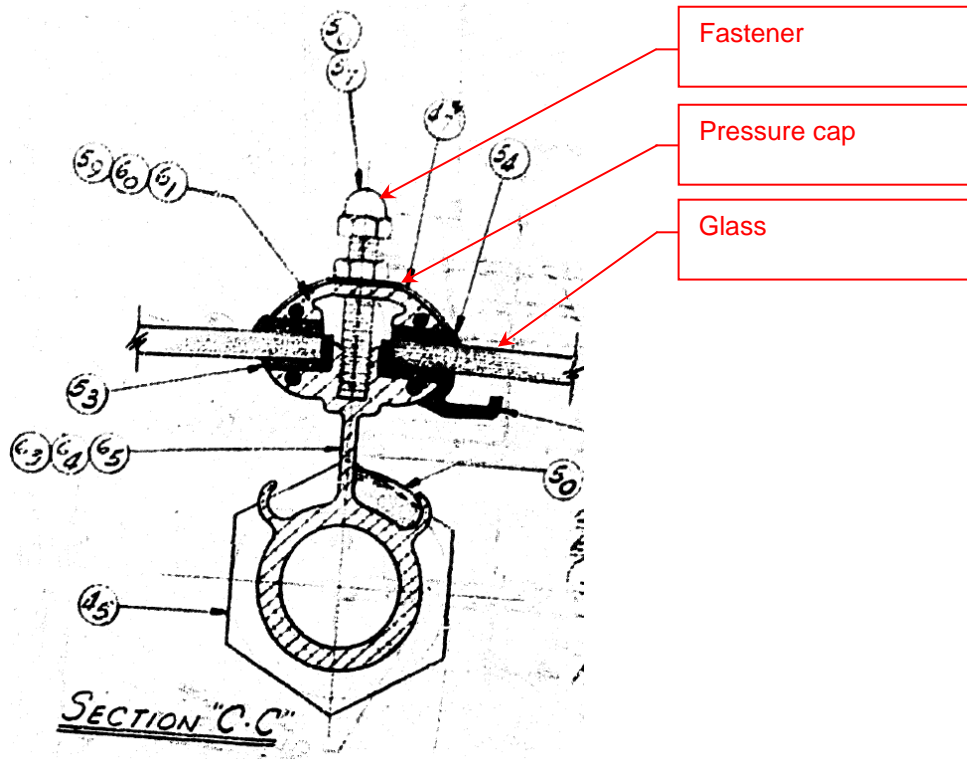
Figure 7. Section through glass and aluminum frame

10. The glass is specified to be 1/4 inch patterned wired glass manufactured by the Mississippi Glass Co., St. Louis, Missouri.
11. The glass is held in place with a pressure cap and fasteners (Figure 7).
