ALASKA DEPARTMENT OF ENVIRONMENTAL CONSERVATION
Division of Spill Prevention and Response
Prevention Preparedness and Response Program
SITUATION REPORT (SITREP)

Day Tank Overflow of Diesel-Learning Center Bethel

SITREP #: 1

SPILL #: 18279900801

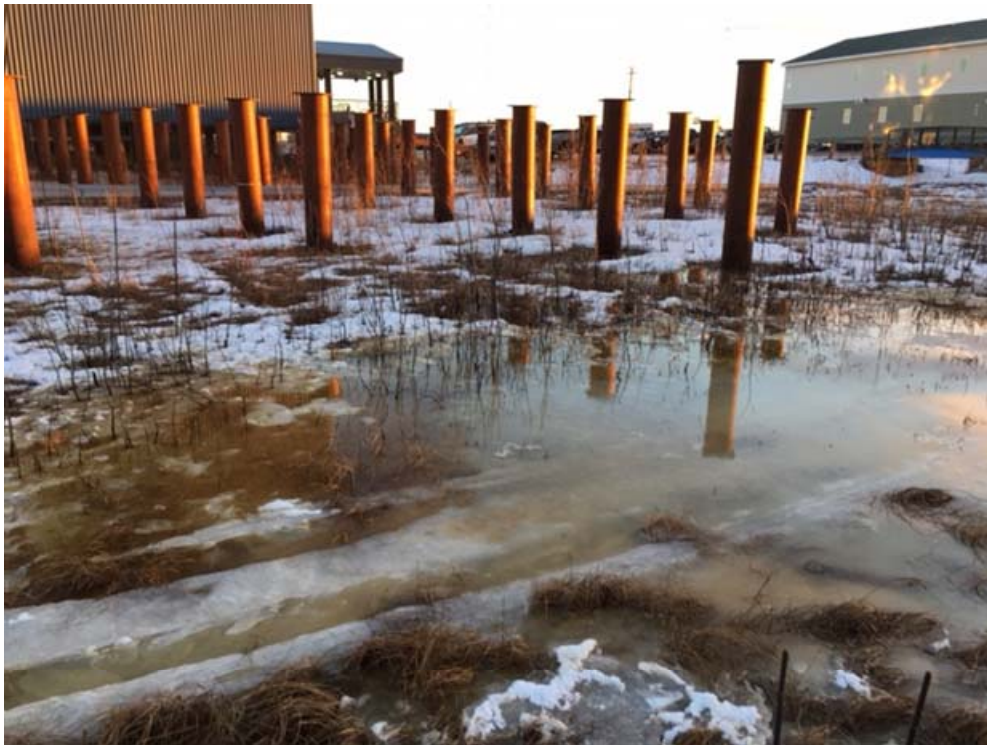
RESOURCES AT RISK OR AFFECTED: The release occurred on the building pad and in the adjacent wetland wetland around the school building. Browns Slough is north of the wetland. Responders reported that the release appears to be in a natural depression and does not appear to have migrated outside the initial spill footprint.

Photograph of release site courtesy of Yuut Elitnaurviat

RESPONSE ACTION: The PRP activated a response contractor Alaska Chadux Corporation (Chadux). The PRP, the Alaska Department of Environmental Conservation (ADEC), and the United States Coast Guard (USCG) formed a Unified Command. Five Chadux responders arrived on site January 9th establishing site control and initiating spill response using absorbents. One more Chadux responder and additional response equipment, including a pump arrived on January 10th. By the end of the operational period January 10th, approximately 400 gallons of diesel and water was recovered from the spill site and transferred into temporary containment. One ADEC responder was deployed to Bethel on January 10th.

At this time the building will remain open. Responders have roped off the release area and the release is away from the building's access points and air intakes.
